Continuous Optimization for Commercial Buildings Program

# Recommissioning Report

Ballenas Secondary School

Project: BCH-07832

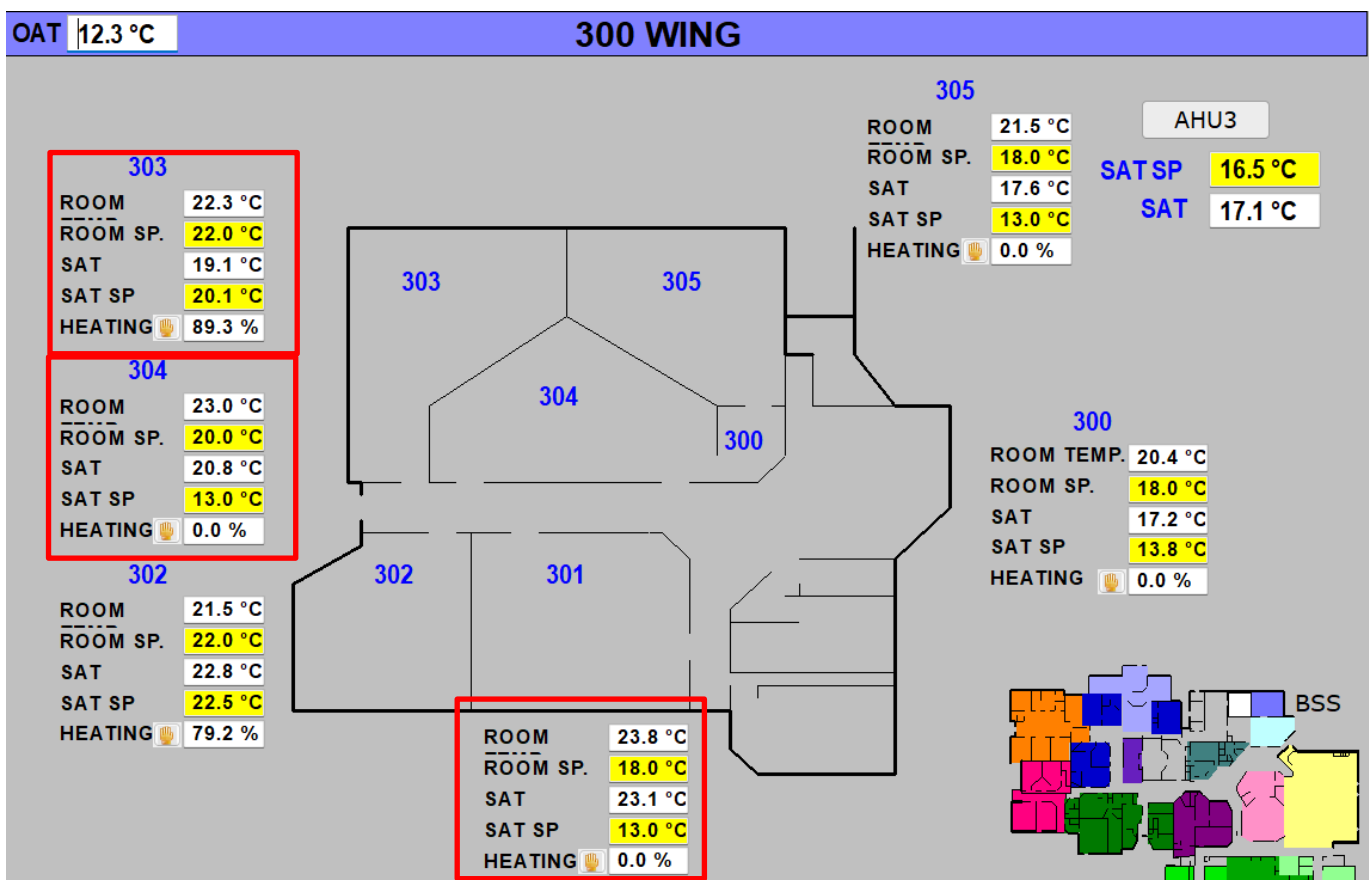
Several reheat coils and their control valves were found to be blocked or passing, see Table 6.

Passing valves result in excessive zone heating. Blocked valves can also cause increased heating because the air handler needs a higher supply air temperature to maintain the setpoint in affected zones. This may result in overheating other zones which do not require extra heating.

AHU-3 reheat coil issues shown here as an example. AHU-3's supply air temperature is 17.3°C at the time Figure 8 was captured. Where reheat coil control valves are fully closed, the reheat coil supply air temperatures should equal the AHU-3 supply air temperature. However, reheat coil supply air temperatures for rooms 301 and 304 are 23.1 and 20.8°C respectively, despite the control valves being fully closed. This suggests the control valves are passing.

The reheat for room 303 is increasing the air temperature to 19.1°C but failing to meet the supply air setpoint (20.1°C) even with the valve almost fully open. AHU-3 is supplying air too hot for rooms 300 and 305. This may be due to Room 303 failing to meet setpoint.

Figure 8: Reheats for 301 and 304 are passing. Reheat for 303 is partly blocked.

We recommend investigating of all reheat coils in the building to identify coils/valves with issues and diagnosing the issue (valve, coil, or actuator). Some cases may be solved with maintenance, but we expect some valves to need replacement.

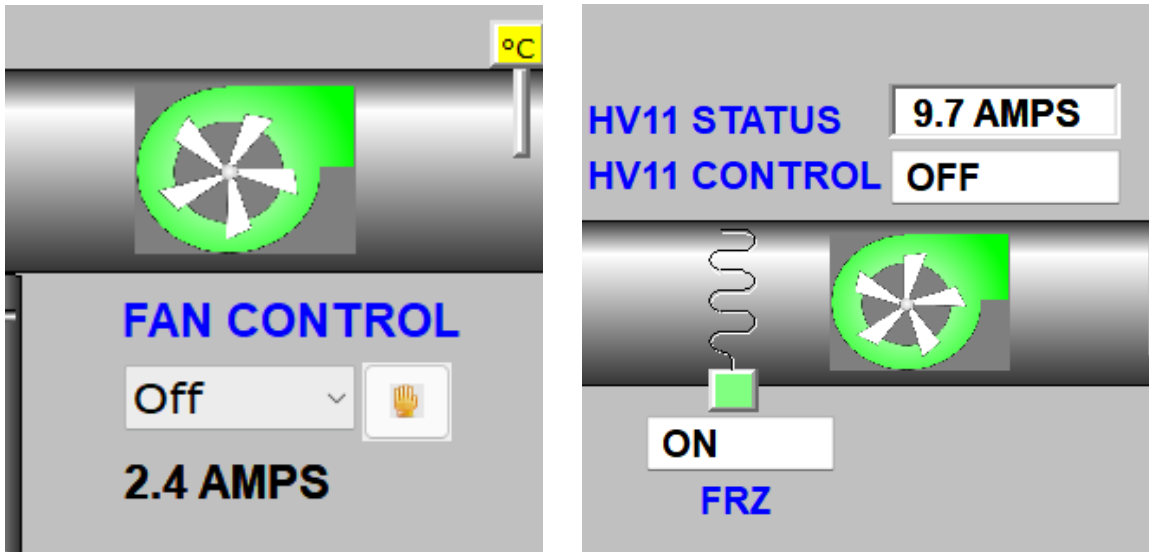
The HV10 and HV11 supply fan feedback sensors report that the fans operate despite being commanded off, see Figure 9.

Figure 9: HV10 (left) and HV11 (right) supply fans

The HV10 supply fan sensor reports 2.4 A when commanded off. This triggers regular operation of the unit, including opening the MAD to its minimum setting (30%), and modulating the heating coils to maintain regular occupied setpoints in the auditorium.

The sensor reports a similar current when the fan is commanded on, which indicates it may be operating continuously.

Verify the HV10 and HV11 supply fan feedback sensors correctly reports that status of the fan by manually checking fan status in the field while commanding the fans on and off.

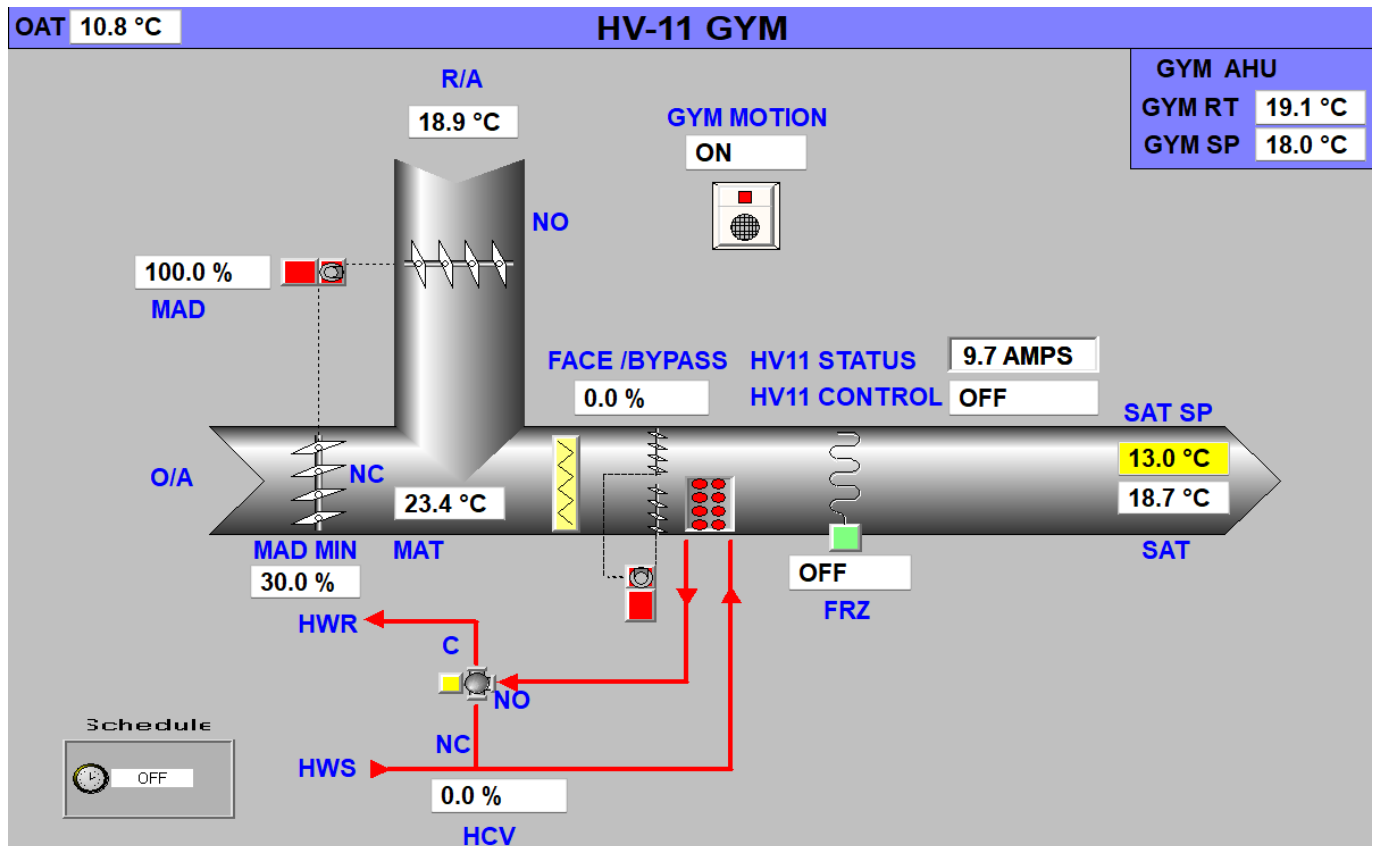
HV11 which serves the gym has the same issue. The sensor reports 9.8 Amp when commanded off, and 17.8 Amps when commanded on, so it is likely this is a sensor function or calibration issue.

Figure 13: HV11 supply fan feedback is 9.7 Amps even when the fan is commanded off

The air handler operates as normal if the supply fan reports it's running, including opening the mixed air damper and heating valve, which can lead to heat losses even if there is no airflow.

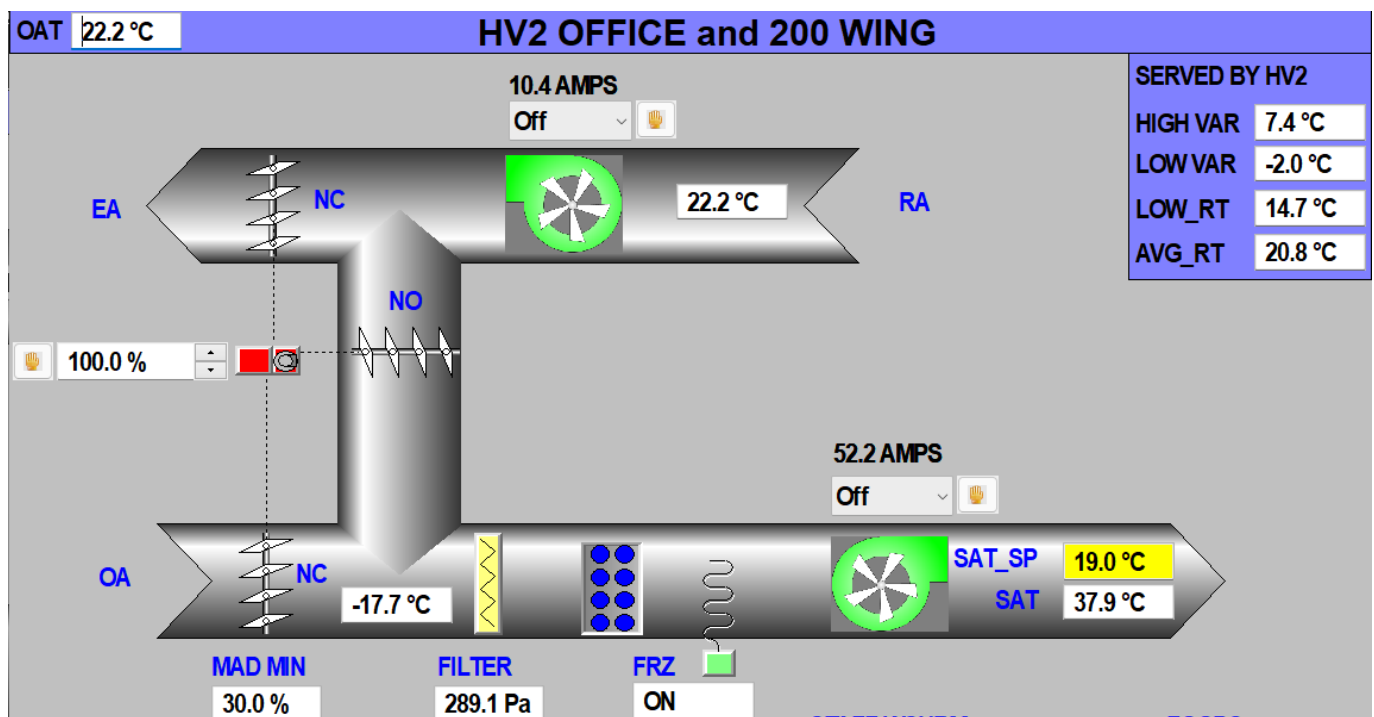
Figure 15: HV2 supply and return fans sensors both indicate fans are running when commanded off

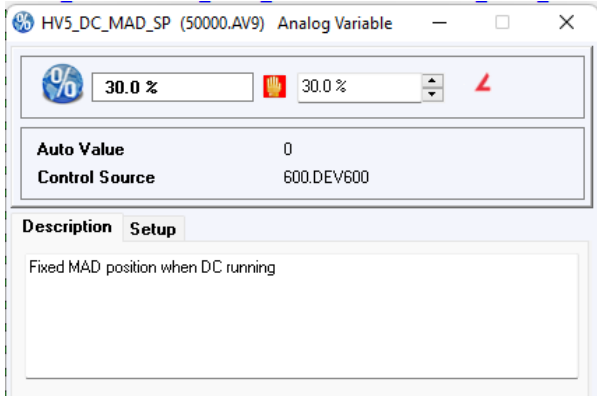
HV5 incorrectly uses the mixed air damper setpoint value in the night setback calculation, see Figure 16. Since this value is fixed to 30% (Figure 17), night setbacks are never enabled for HV5.

Figure 17: HV5 mixed air damper setpoint is manually set to 30%

Correct HV5 night setback programming to use room temperature.

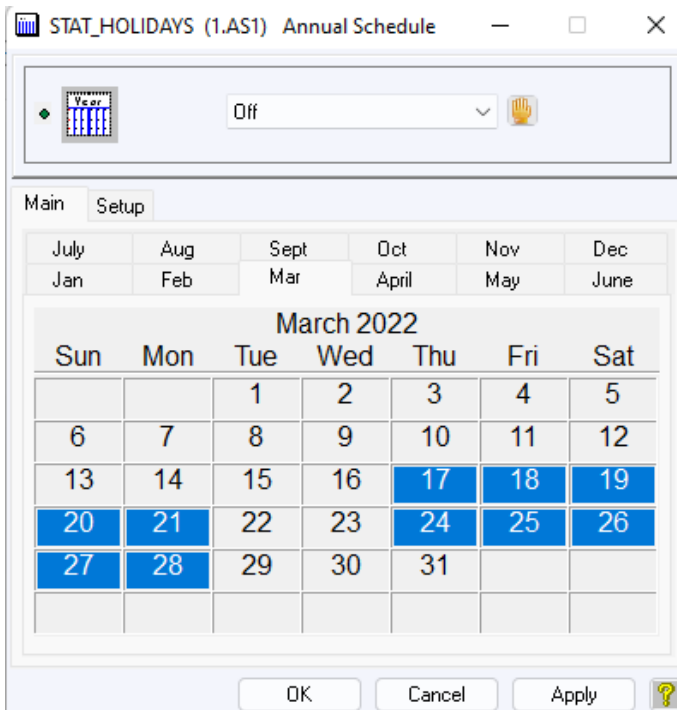
The holiday schedules for spring and summer breaks do not match the actual school calendar. The spring break schedule is offset from actual weekdays. The summer break schedule only covers part of July and August.

Figure 18: Spring break exception schedule

Update holiday schedules for all air handlers to match school calendar on a regular basis.

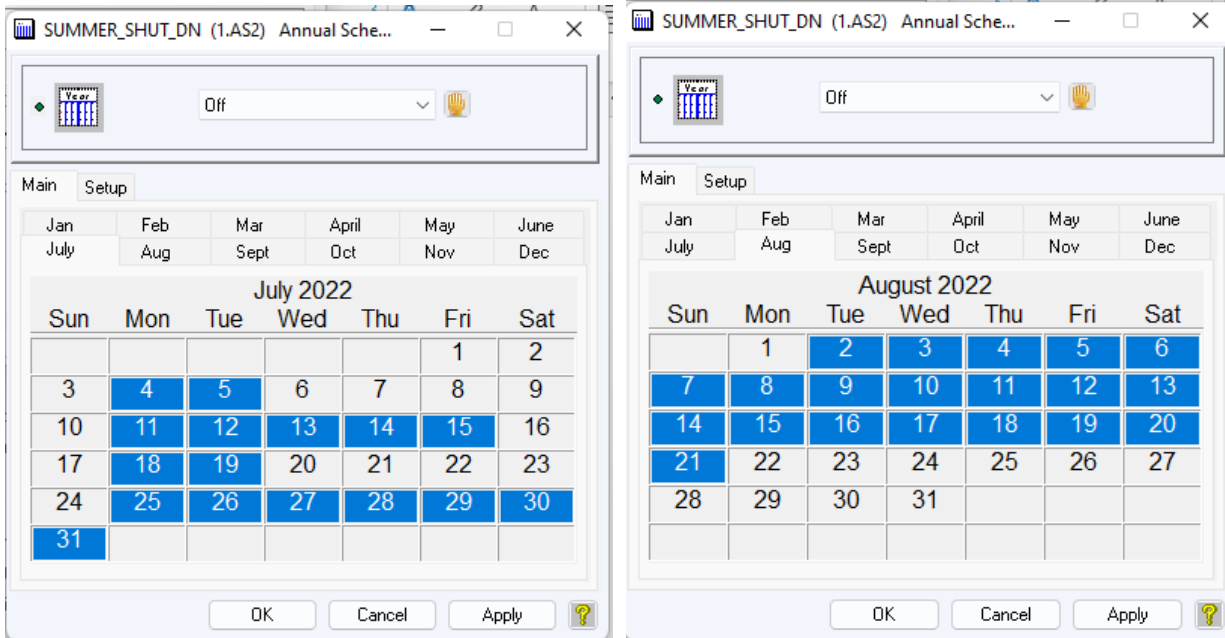
**Figure 19: Summer break exception calendar**

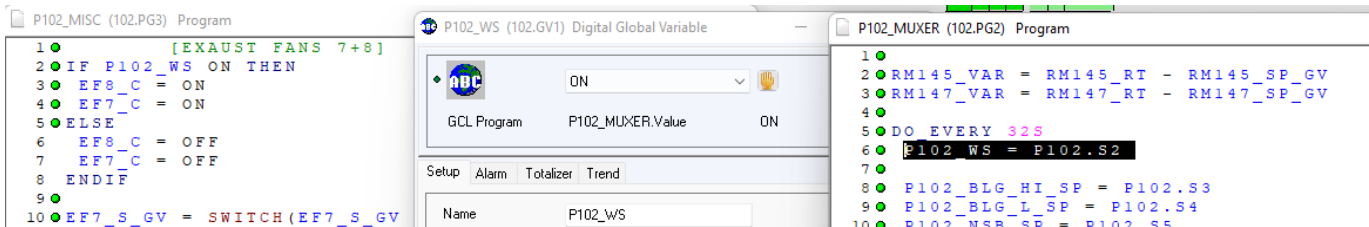
EF7 and EF8 are operating continuously. Both are programmed to operate per weekly occupancy schedules that no longer exist in the DDC as seen in Figure 20.

**Figure 20: EF7 and EF8 calendar logic**

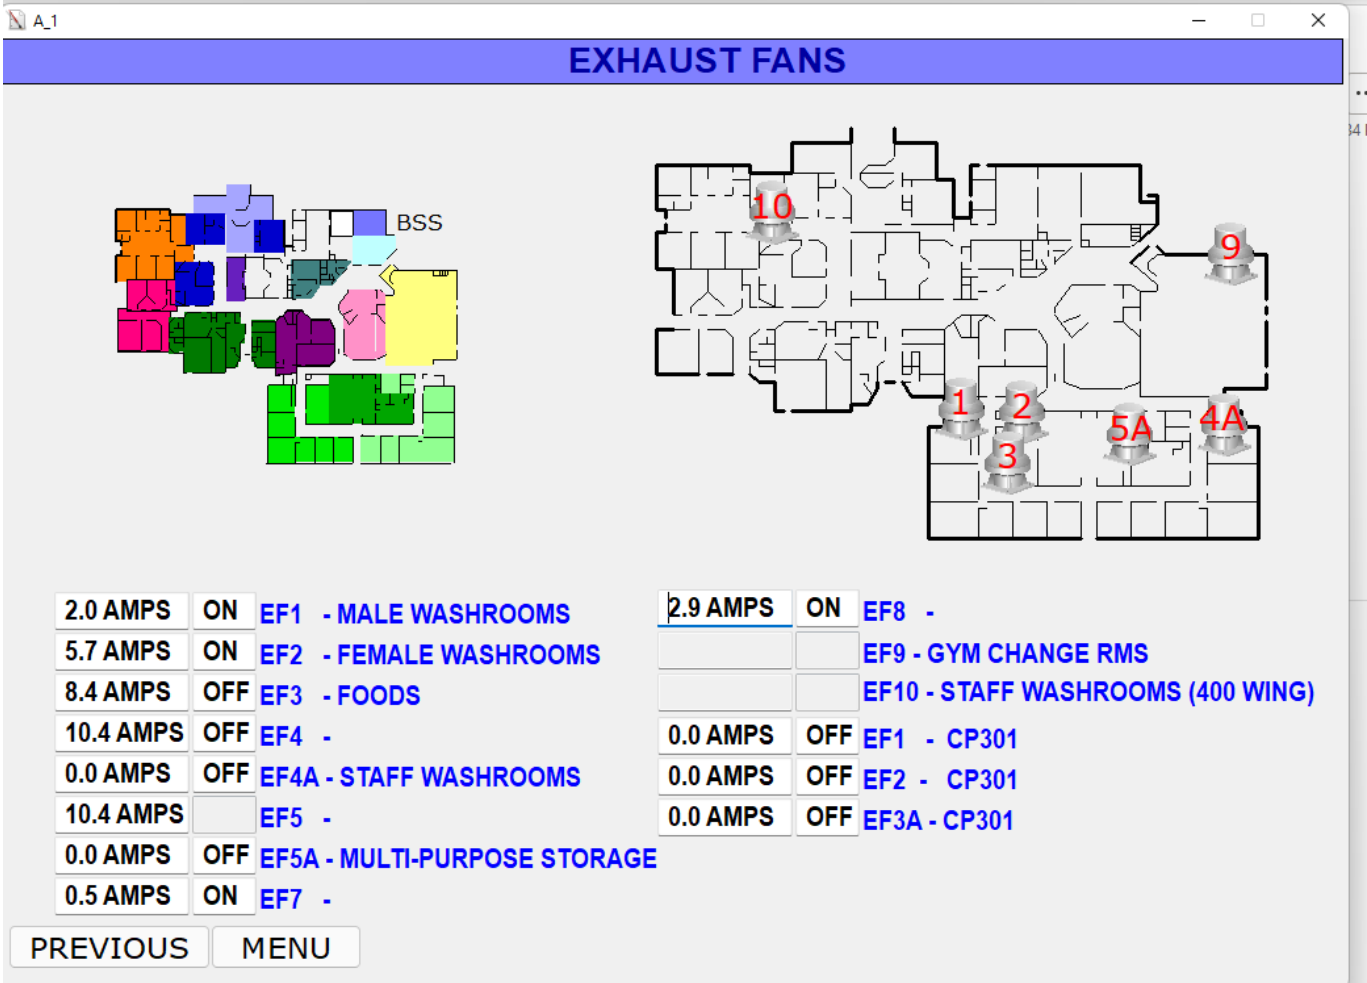
Several exhaust fans were found to be running while the building was unoccupied, see Figure 21. Unless there are specific needs, such as moisture/pollutant control, they should be switched off when the building is unoccupied.

EF1 and EF2 are overridden on. This causes them to operate continuously.

EF4, EF5, and EF9 feedback sensors show each operates when commanded off.

Figure 21: Exhaust fans overview, at 10:24pm on a Sunday

Verify correct operation of EF4, EF5, and EF9 fans and the feedback sensors in the field. Replace the sensors or control wiring as indicated by field tests.

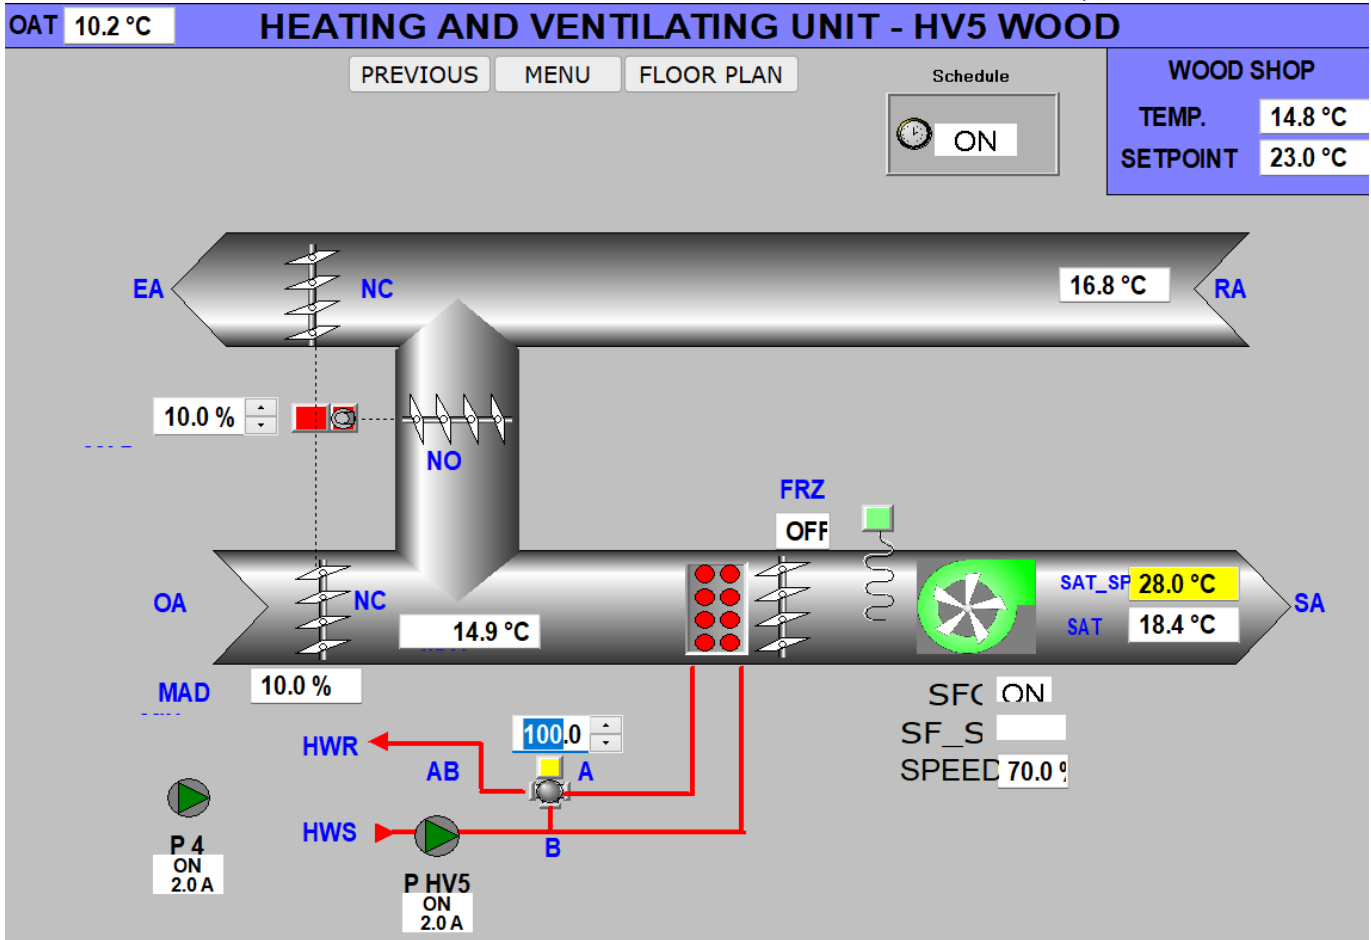
HV-5 is struggling to meet its supply air and zone temperature setpoints despite its heating coil control valve fully open as seen in Figure 22.

Figure 22: HV-5 has low supply air temperature even with heating valve fully open

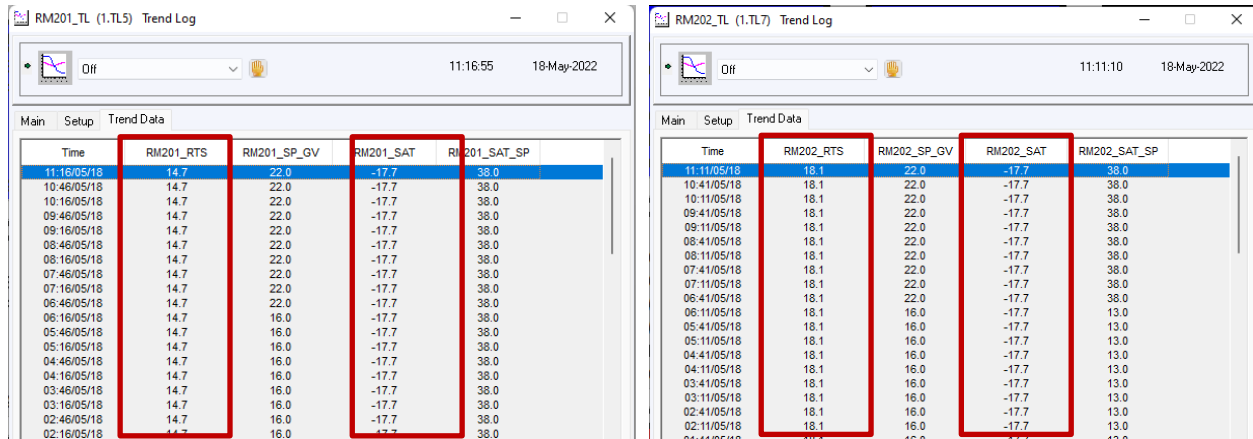
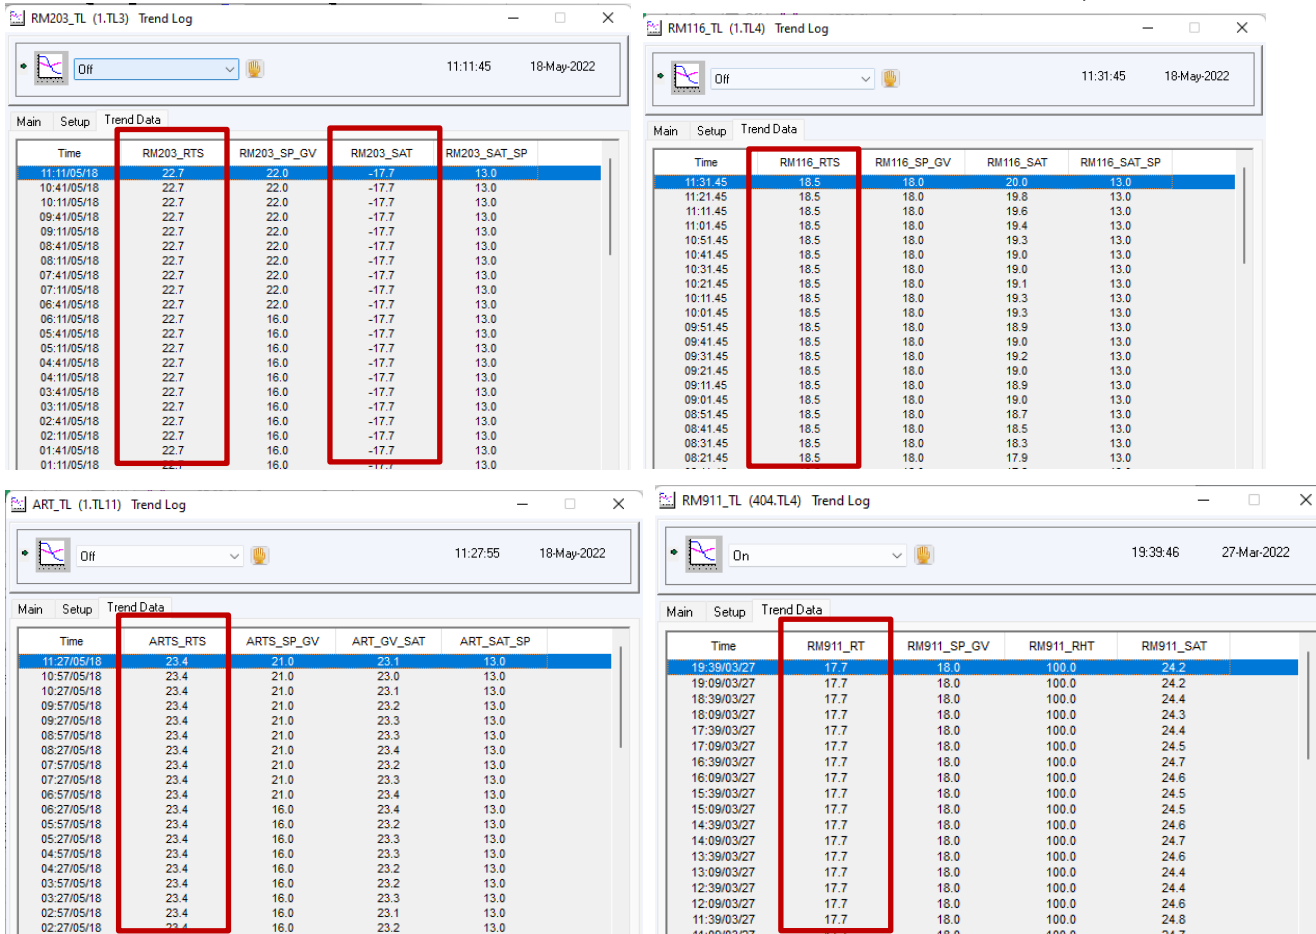
Low supply air temperature readings can cause unnecessary reheat. Low room temperature readings can cause unnecessary reheat as well as overnight “night setback” operation of air handlers.

**Figure 24: Failed room temperature and SAT sensors for RM201, 202, 203, 116, ART ROOM, 911**

The RM911 room temperature sensor is stuck at 17.7°C which is lower than NSB SP (19°C). During the investigation period, the low RM911 room temperature was observed to trigger HV2A to run during unoccupied times.

Replace the problem temperature sensors.

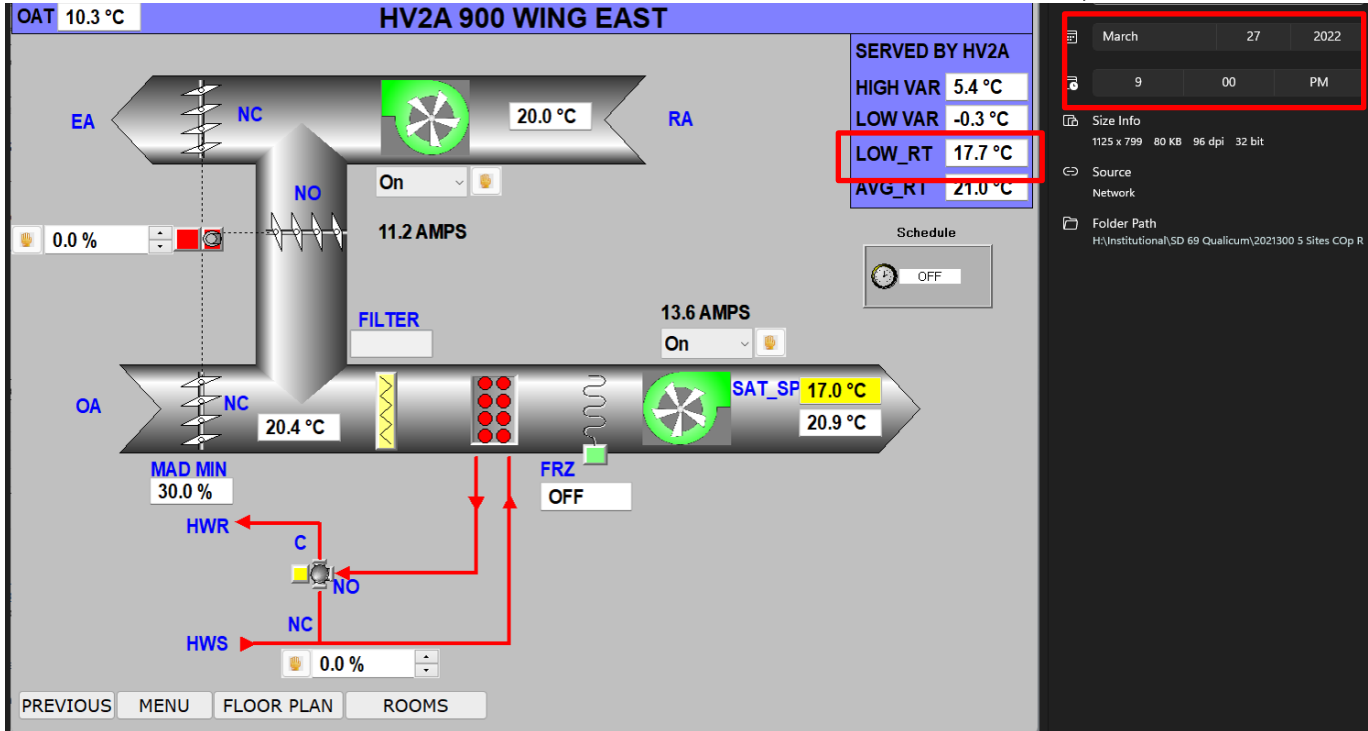
Figure 26: HV2A operating outside scheduled hours

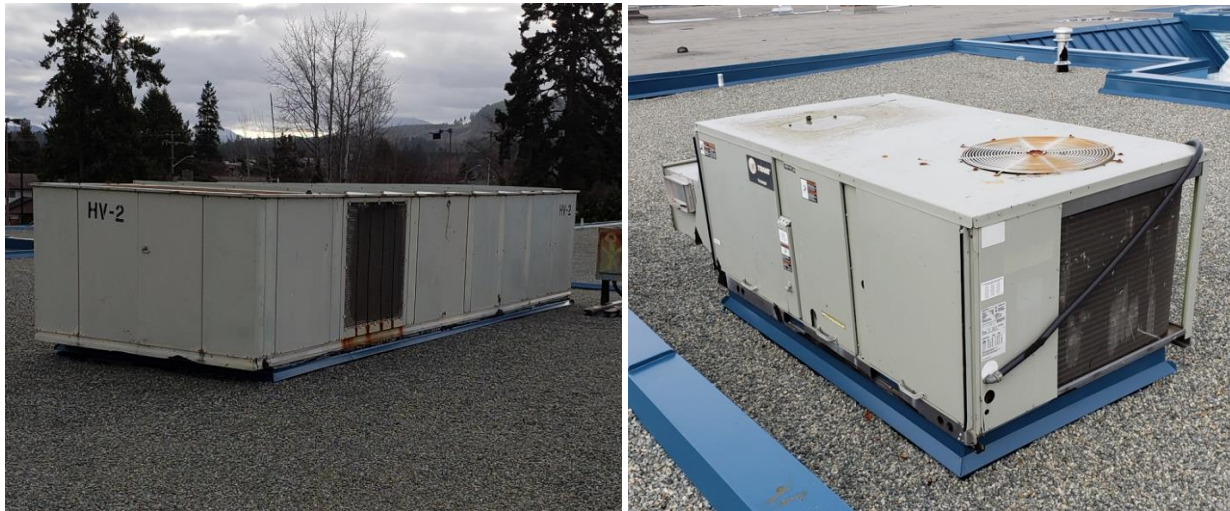
**Figure 27: HV2 and HV4 rooftop units with DX cooling**

When these DX systems reach end-of-life, they can be upgraded to reversible heat pumps of similar capacity. This will enable them to provide 1<sup>st</sup> stage heating, supplemented by heating coils like the existing ones. Our high-level estimate is that new replacement units would cover all the heating needs for areas served by these air handlers.

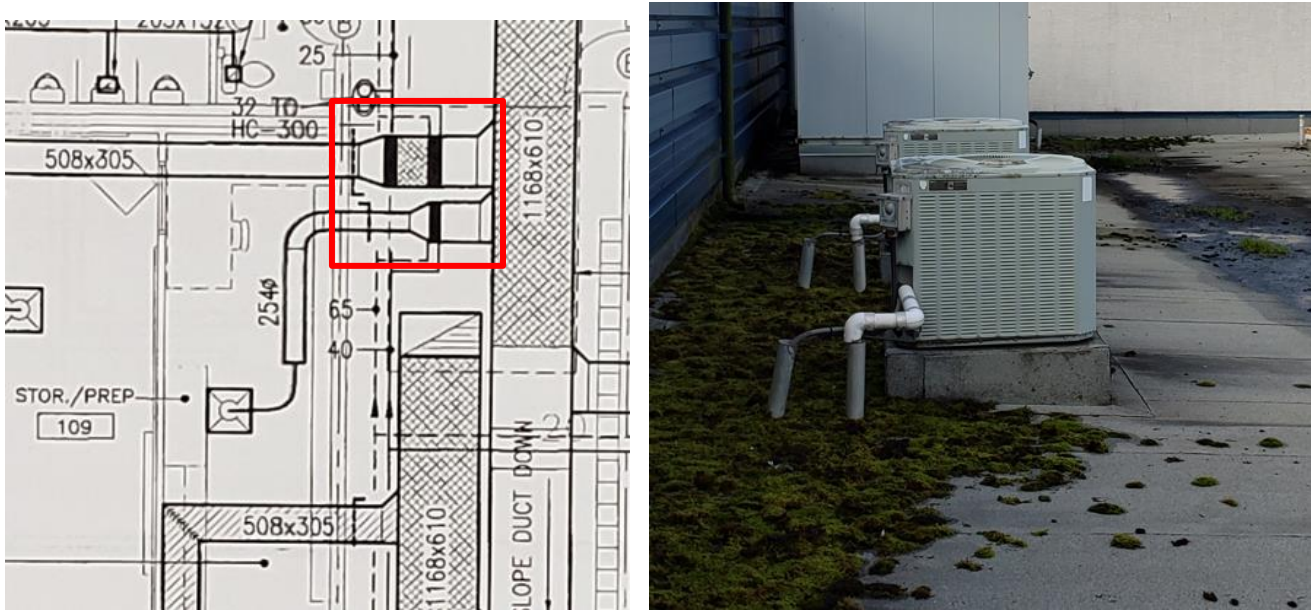
Four 4-ton split systems provide cooling to classrooms 901, 903, 912, and 913 using dx coils in the ducts from HV2A and HV3A.

Figure 31: DX coils and outdoor units provide cooling to four rooms in the 900 Block.

Estimated measure costs include all work required to replace each existing cooling system with a reversible heat pump. The base case cost (replacing the equipment like-for-like) may be similar. The ASHRAE life expectancy for air cooled condensers is 20 years, so these units should need to be replaced in 5 to 10 years.

CU-1 to CU-4 (Figure 31) Figure 31: DX coils and outdoor units provide cooling to four rooms in the 900 Block.) would be relatively simple swaps with equivalent reversible units.

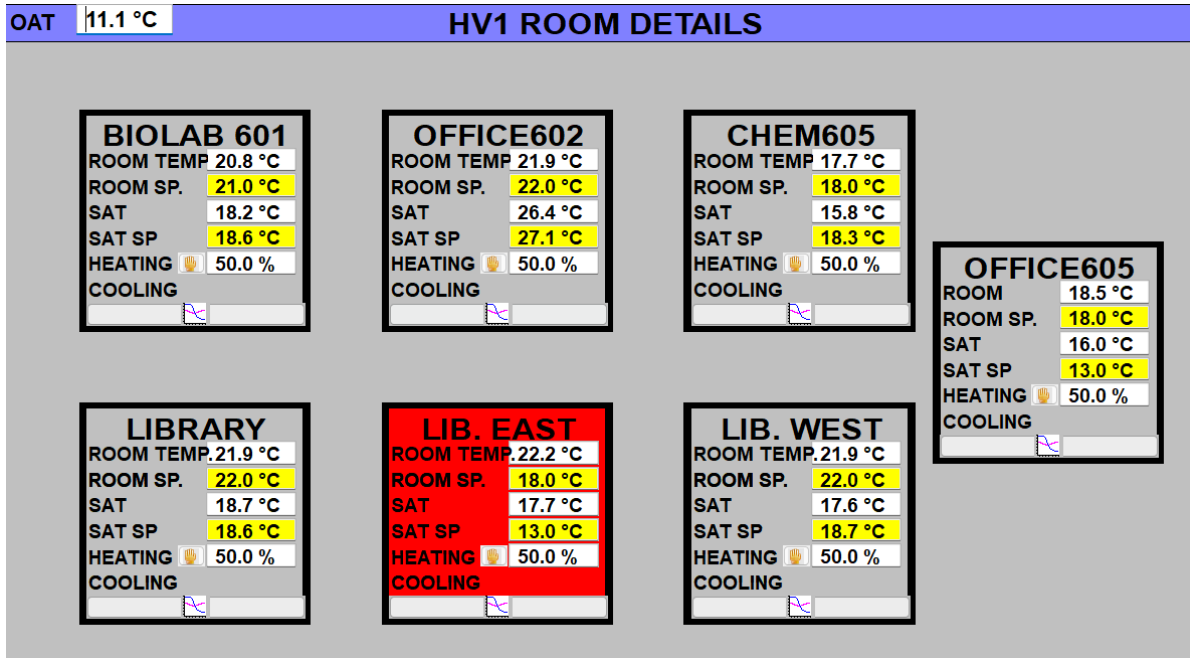
Figure 32: AHU4 room details (note the title is wrong)

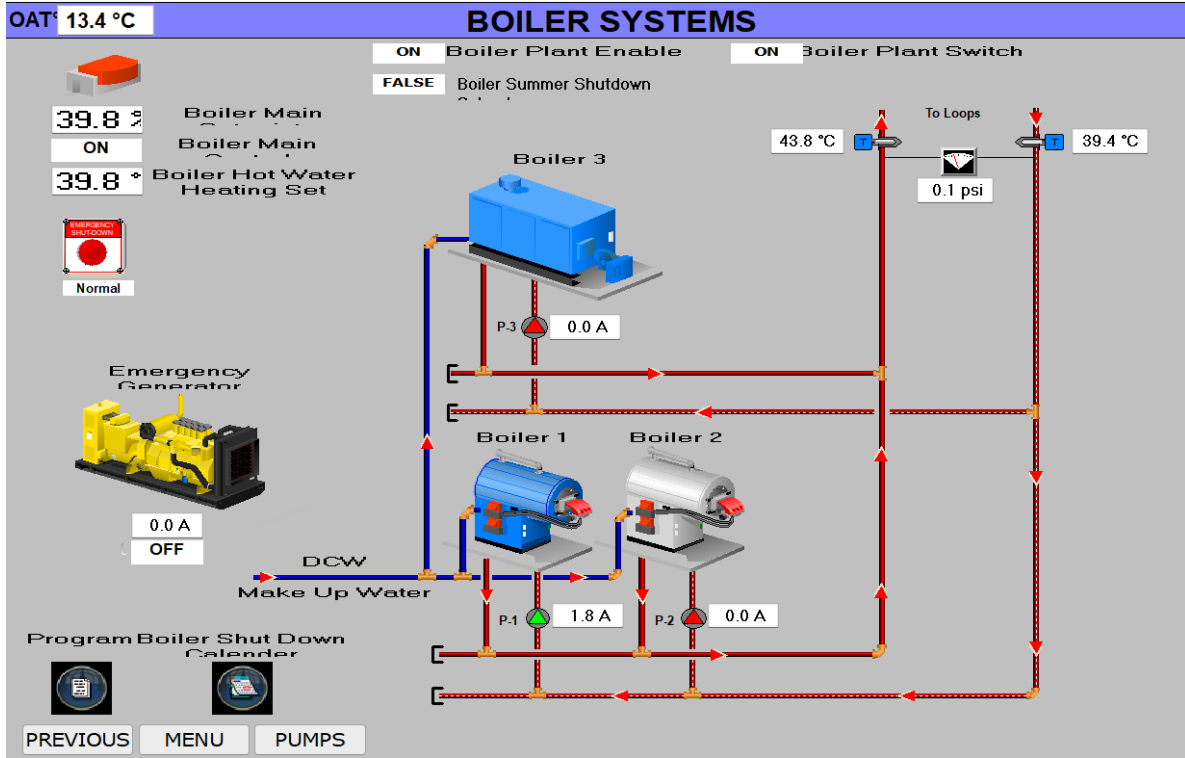
Figure 33: Boiler loop losing over 4°C even with all AHUs off

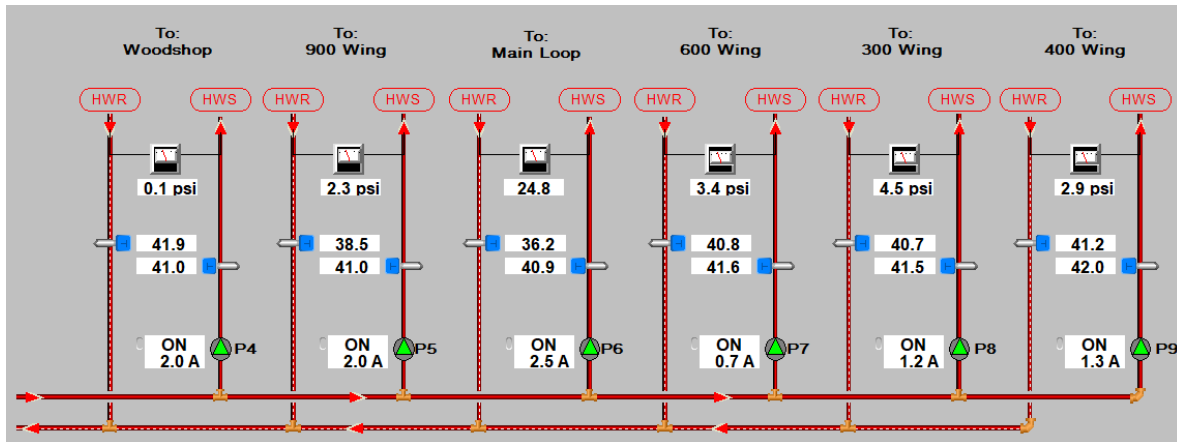
Figure 34: Biggest temperature drop is in the main loop
