FINANCE & OPERATIONS COMMITTEE OF THE WHOLE

School District 69 Qualicum – Strategic Energy Management Proposal in partnership with BC Hydro

Continuous Optimization for Commercial Buildings Program

Recommissioning Report

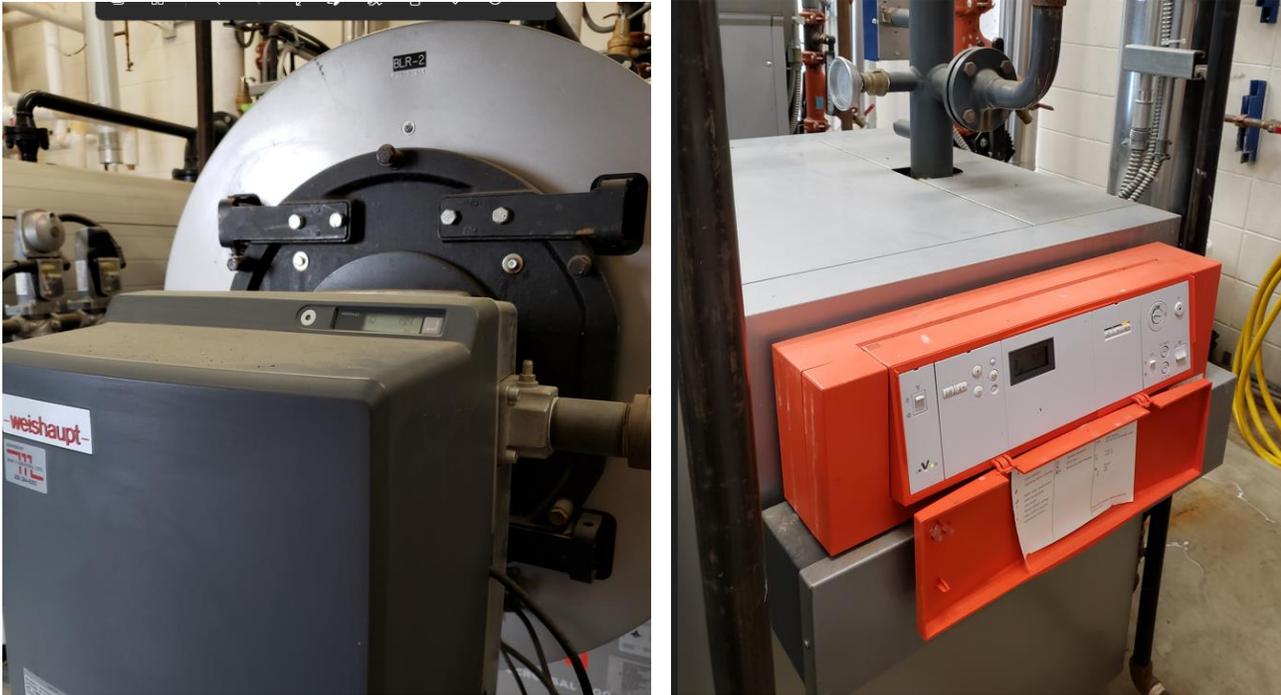
Boiler	Area
B-1	Veissmann Vitocrossal 200 condensing boilers
B-2	1071 MBH (input)
B-3	Veissmann Vitorond 200 non-condensing 1096 MBH (input)

Figure 1: Boilers B-2 (left) and B-3. B-1 is the same make and model as B-2.

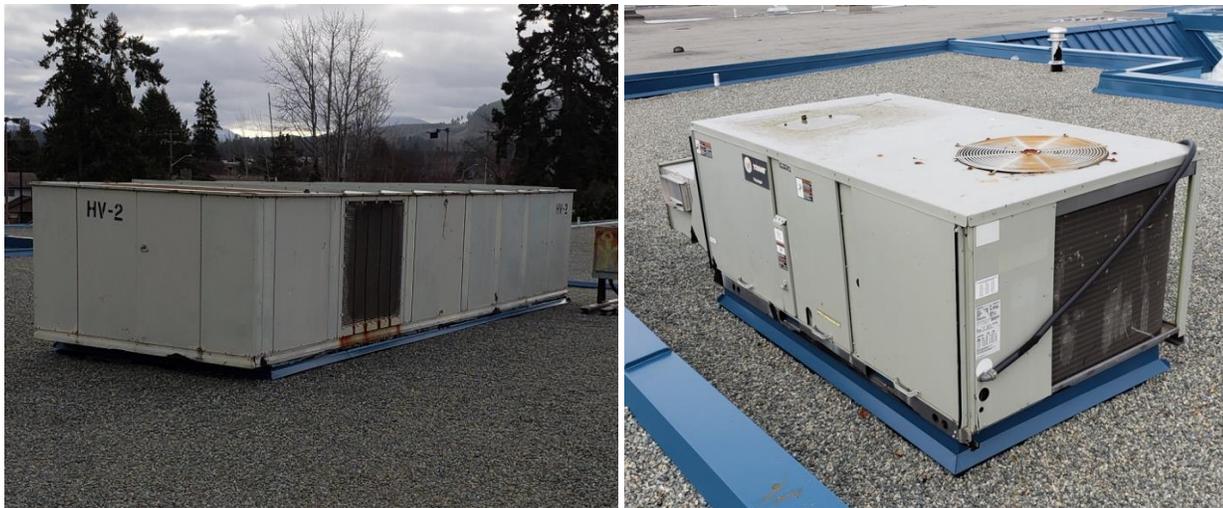
Tag	Size	Age	Description	Replacement
HV2	23 Ton 9500 cfm	Pre-1996	Packaged roof-top unit (Lennox DMS4-275HW) with DX coil and hydronic heating coil	Similar sized unit with reversible heat pump
HV4	6 Ton 2000 cfm	2001	Packaged roof-top unit (Trane TFD075) with DX coil, hydronic heating coil	Similar sized unit with reversible heat pump
HV8AC8	28 Ton 10,000 cfm	1991	Air handler (Engineered Air FWA-285-C). Air inlet and outlets, condensing coils and fans are in a small courtyard. The rest of the unit is in a mechanical room.	Similar sized unit with external condensing unit.
HV11A	12 Ton 2,400 cfm		Packaged roof-top unit with DX coil and hydronic heating coil	Similar sized unit with reversible heat pump
CU-1 to CU-4	4 Ton condensing units	2001	Rooftop condensing units (Trane TTA048) with indoor coils in supply air ducts leading to four classrooms in 900 block.	Similar sized reversible units

Figure 27: HV2 and HV4 rooftop units with DX cooling

Estimated measure costs include all work required to replace each existing cooling system with a reversible heat pump. The base case cost (replacing the equipment like-for-like) may be similar. The ASHRAE life expectancy for air cooled condensers is 20 years, so these units should need to be replaced in 5 to 10 years.

A feasibility study is recommended as the next step to assessing the viability of this project. Mechanical and structural assessments are required to refine the cost and viability of the project.
