School District 69 Qualicum – Strategic Energy Management Proposal in partnership with BC Hydro

# Recommissioning Report

Oceanside Elementary School

Project: BCH-07834

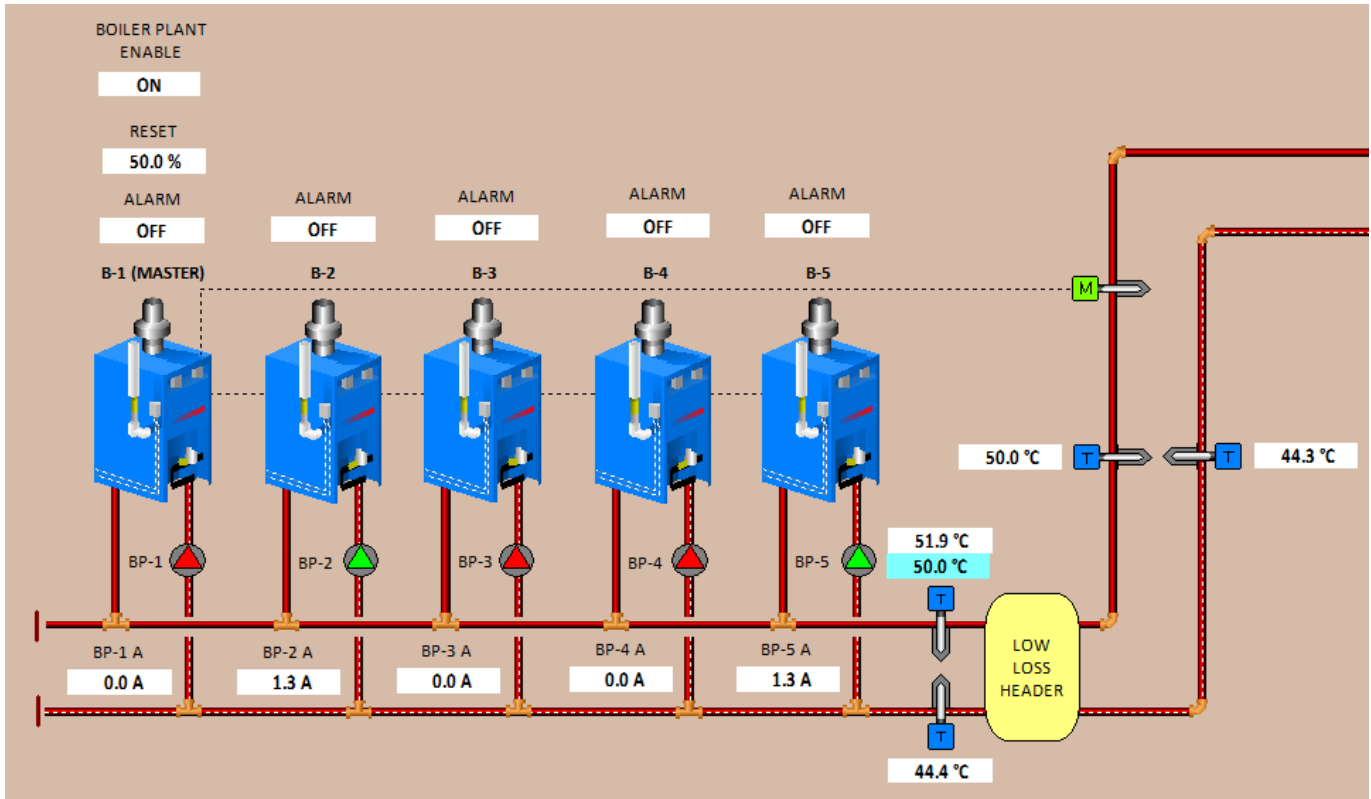
Heating is provided by five 399 MBH (input) IBC condensing gas boilers. Each boiler has its own circulating pump. The primary boiler loop is connected to the secondary loop via a low loss heater. The supply water setpoint for the primary loop has been manually set to 50°C.

**Figure 2: Boilers in the DDC**

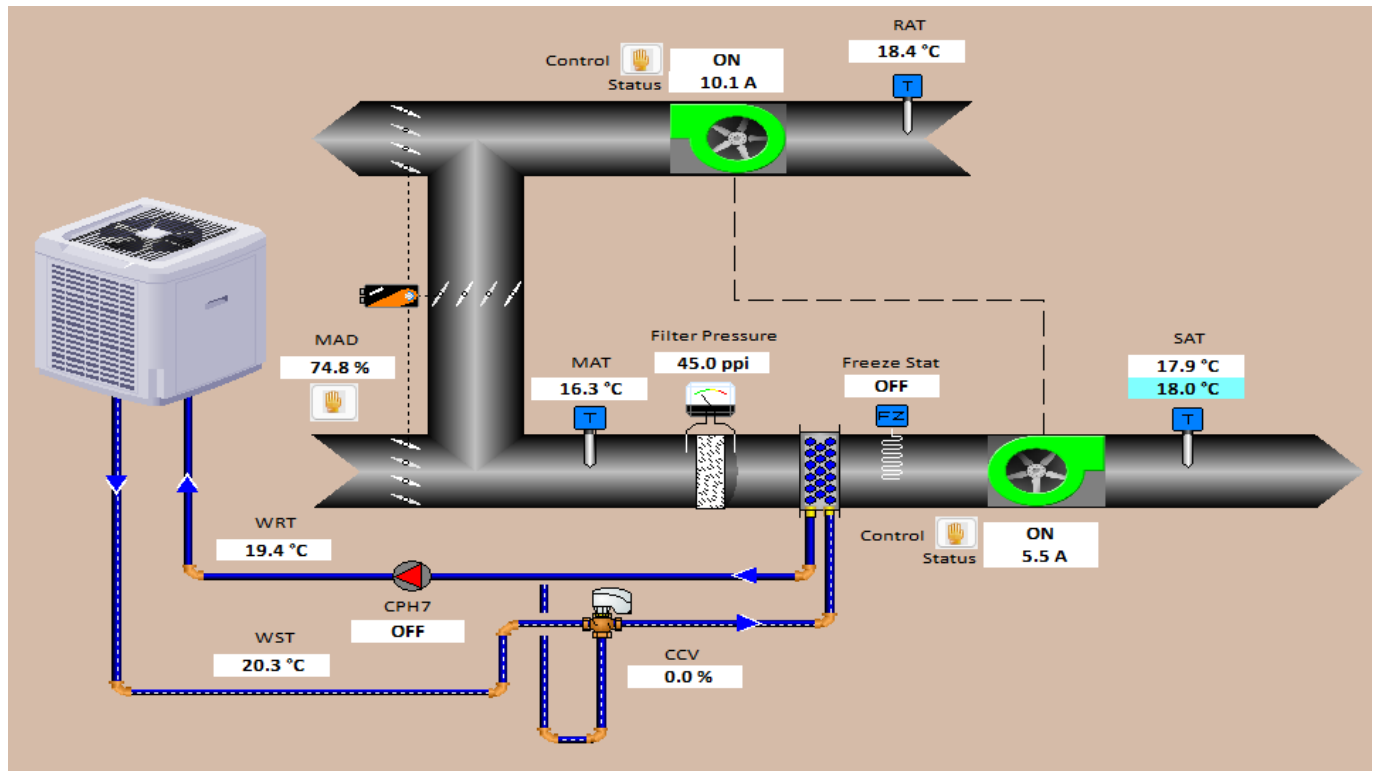
Details of the existing chiller have not been made available, but based on AC-1 cooling coil specification, we estimate the chiller capacity is around 25 Tons.

Figure 3: AC-1 and chiller

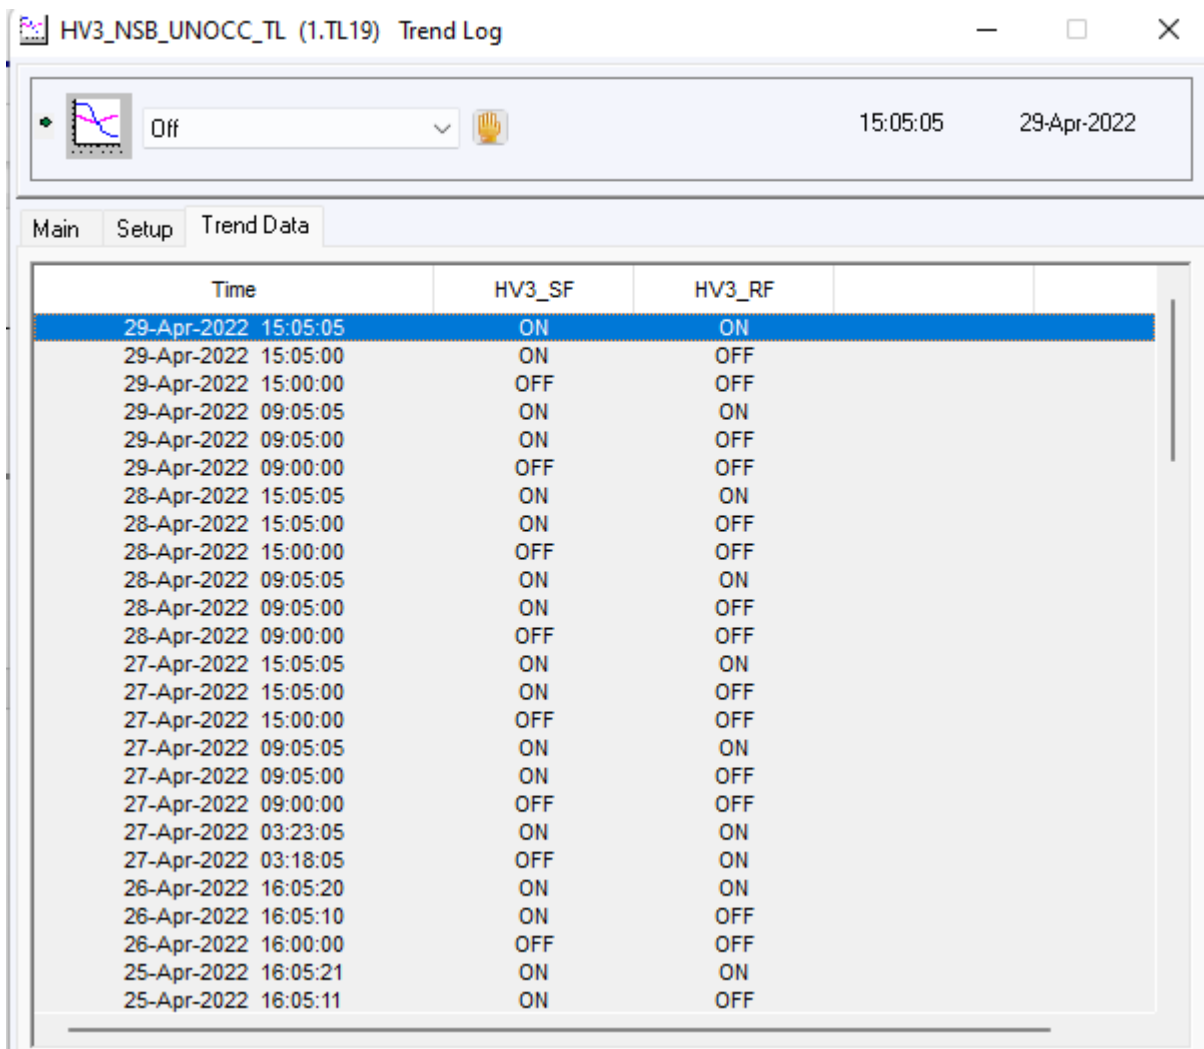
HV-3 operates continuously, including during its scheduled unoccupied hours. Outside of scheduled occupied hours, HV-3 is programmed to start if the temperature of the coldest zone it serves is below its night setback setpoint (19°C). However, this variable (HV3\_LOW\_RT) is always 0, apparently because it is calculated using sensors that have been removed.

Figure 12: HV-3 fans run except for brief stops when occupancy mode changes

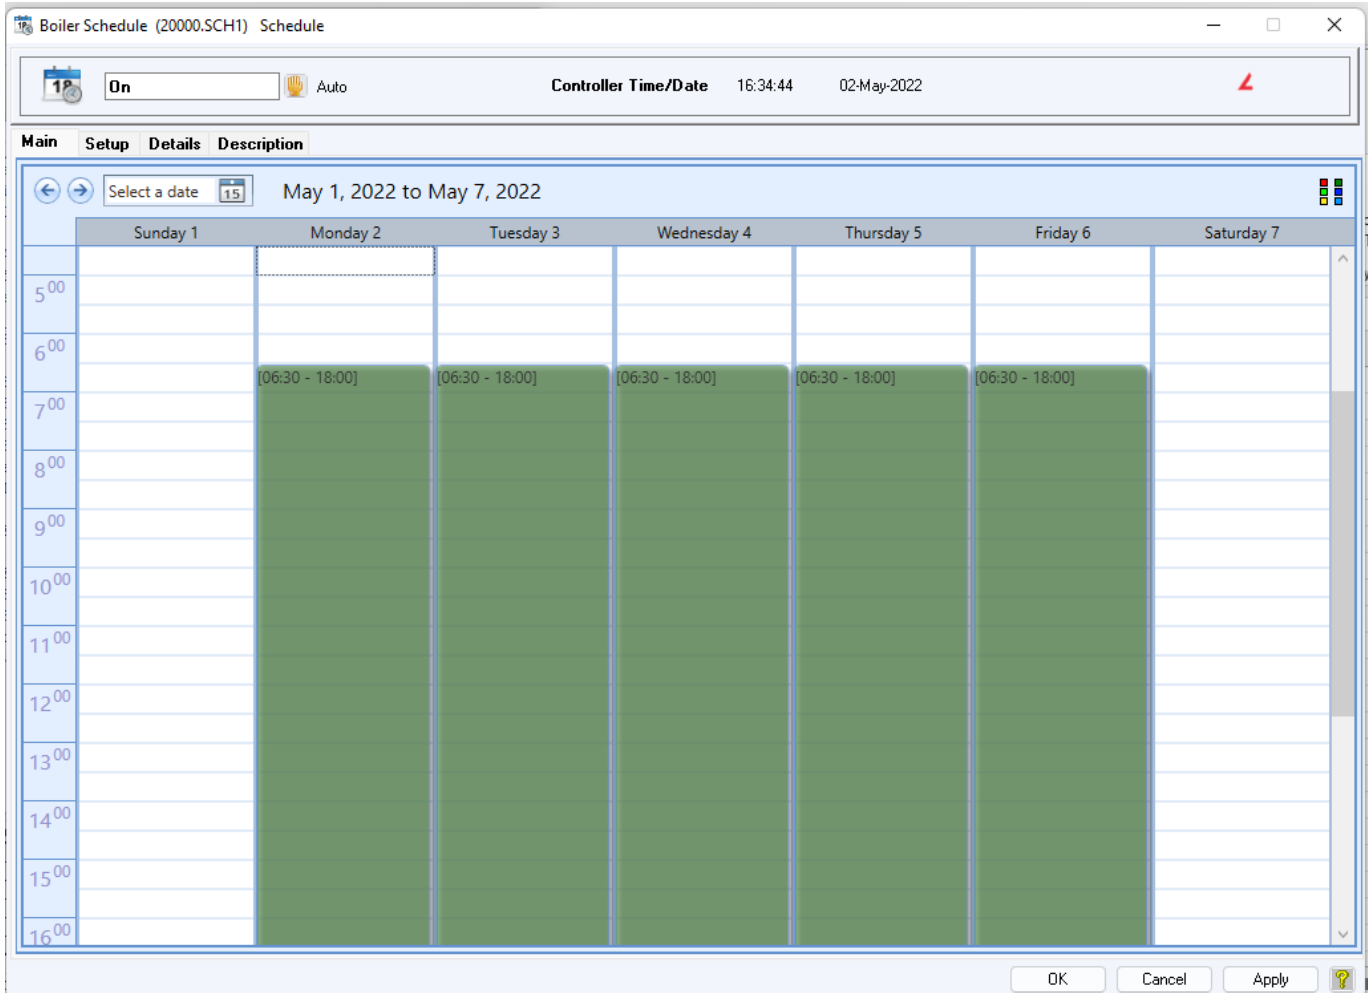
**Figure 19: Boiler temperature is set to 60°C when unoccupied**

**Figure 20: Boiler schedule**

Reducing the room temperatures while unoccupied will reduce heat loss through the envelope (walls, windows, etc.) and save energy. We recommend reducing room temperature setpoints for all equipment to 15°C during unoccupied periods.

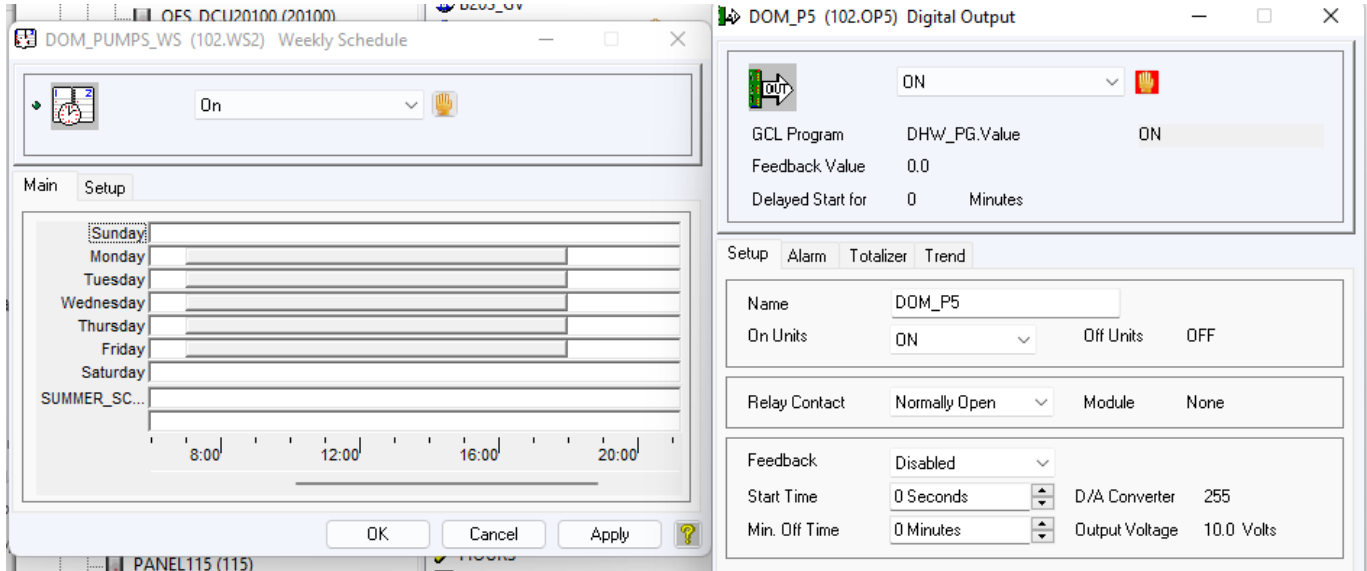
Running the pump outside of scheduled hours causes a (small) energy penalty and distribution losses.

**Figure 27: The P-5 schedule has been manually overridden**

The purpose of the pump is to ensure hot water immediately at taps and showers throughout the building, so it should run whenever custodial staff or other occupants are in the building.

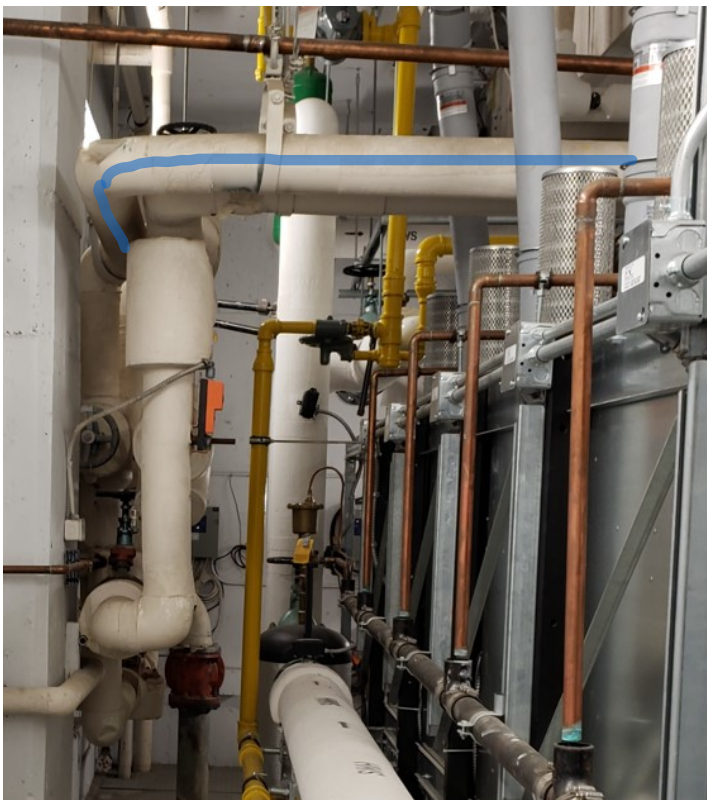
**Figure 28: Basement mechanical room. Chiller water pipe marked in blue. The boilers are on the right.**

A feasibility study is recommended as the next step to assessing the viability of this project. The boiler plant's heating water supply temperature should be trended through winter to confirm the fraction of the year a heat pump could supplement Oceanside's heating. Mechanical and structural assessments are required to refine the cost and viability of the project.

Estimated measure costs include all work required to replace the existing chiller with a heat pump. If the existing AC-1 chiller is nearing end-of-life, the base case cost (replacing the chiller like-for-like) may be similar.

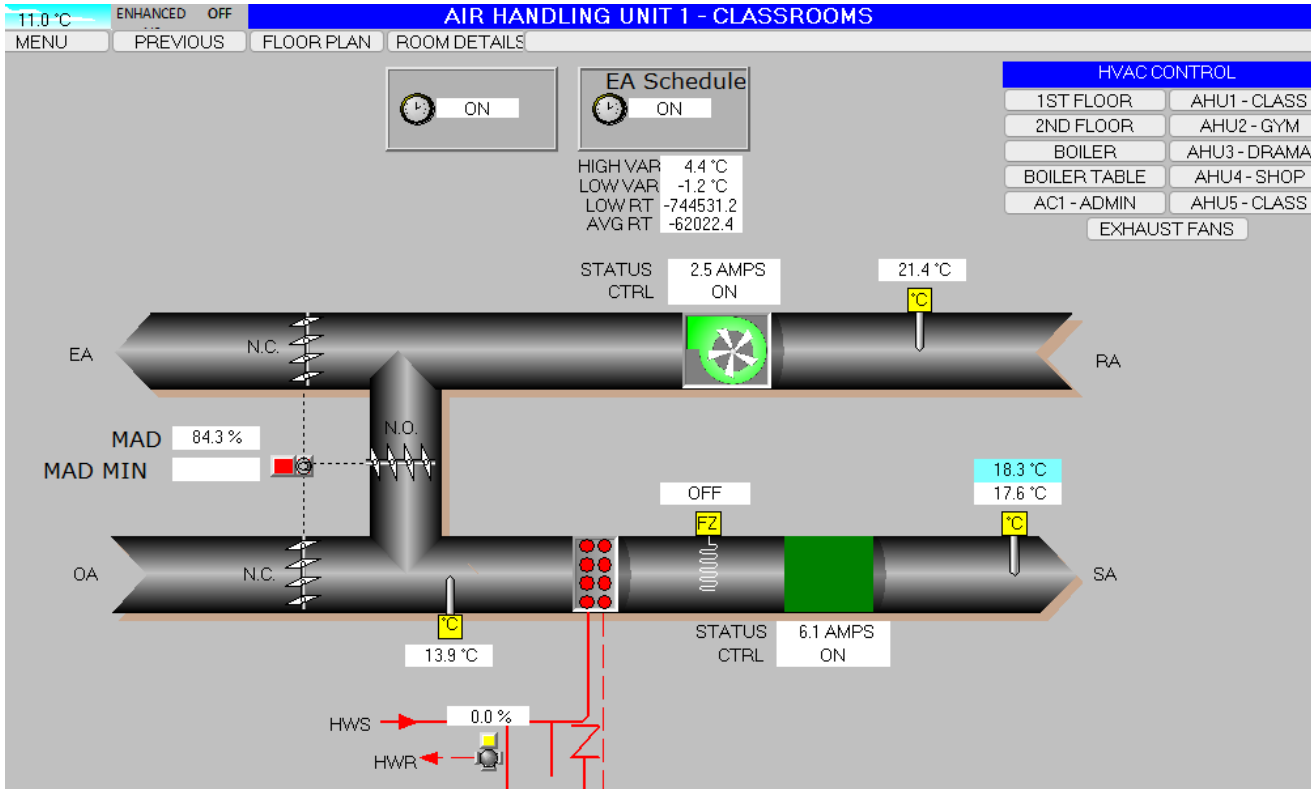
AHU-1 is programmed to start during unoccupied hours if the lowest room temperature (*AHU1\_LOW\_RT*) is less than 16°C per Figure 9. However, the lowest room temperature is often a random negative value. This causes AHU-1 to run continuously.

Figure 8: AHU-1 DDC Graphic

Replace any failed sensors used to calculate AHU1\_LOW\_RT and remove any sensors from its calculation that no longer exist.

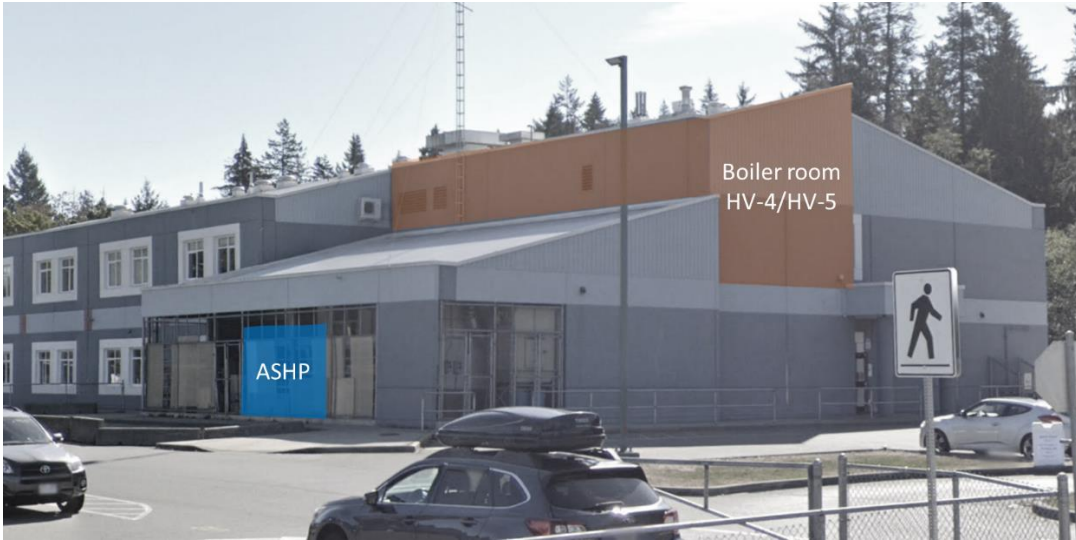
Figure 21: Possible location for ASHP in the covered storage/dust collector area

A feasibility study is recommended as the next step to assessing the viability of this project. Heating water supply temperatures, and heating coil performance should be trended through the heating season to confirm the heat pump could operate for most of the heating season. Mechanical and structural assessments are required to refine the cost and viability of the project.

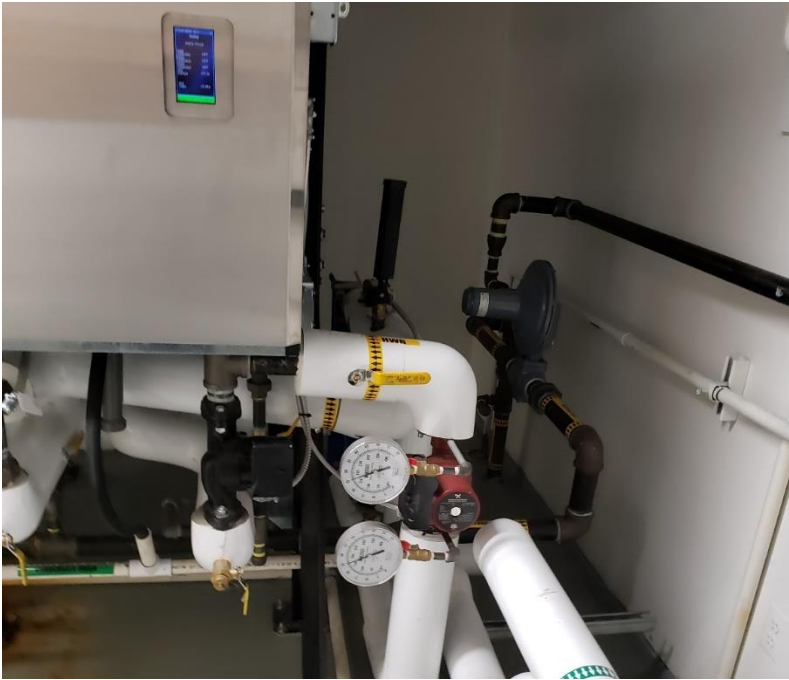
**Figure 2: B-1 supplies both DHW and space heating via two boiler pumps**

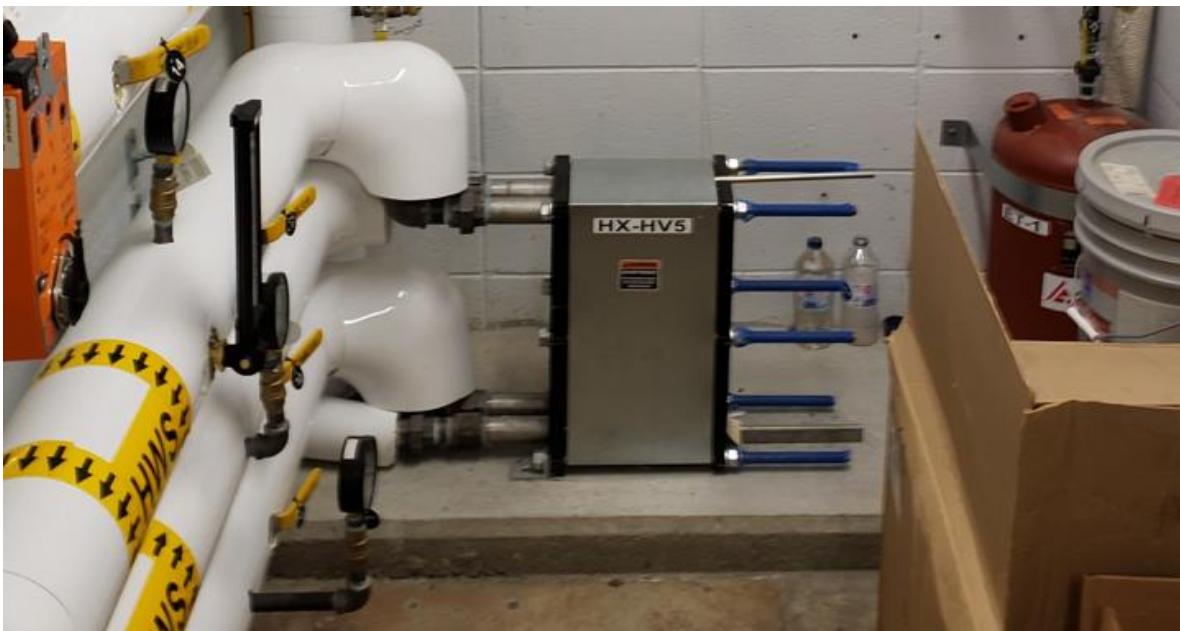
A glycol heating loop serves the heating coil in HV5; this is heated by heat exchanger HX-HV5, see Figure 4.

Figure 4: HX-HV5 heat exchanger

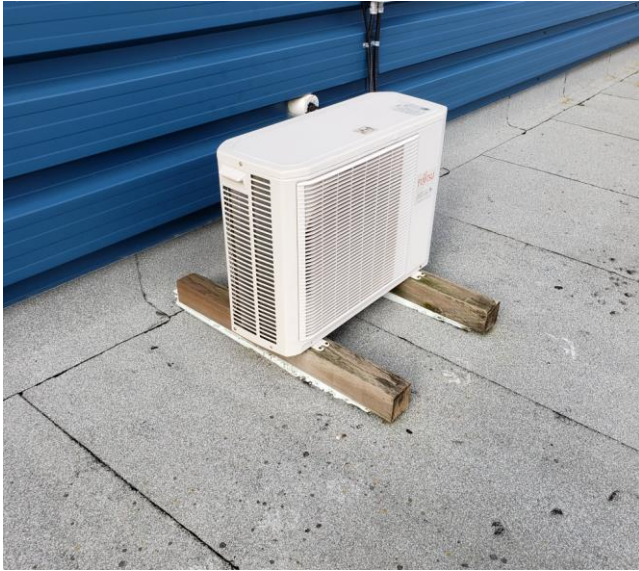
Figure 5: Additional Fujitsu split unit above multi-use area.

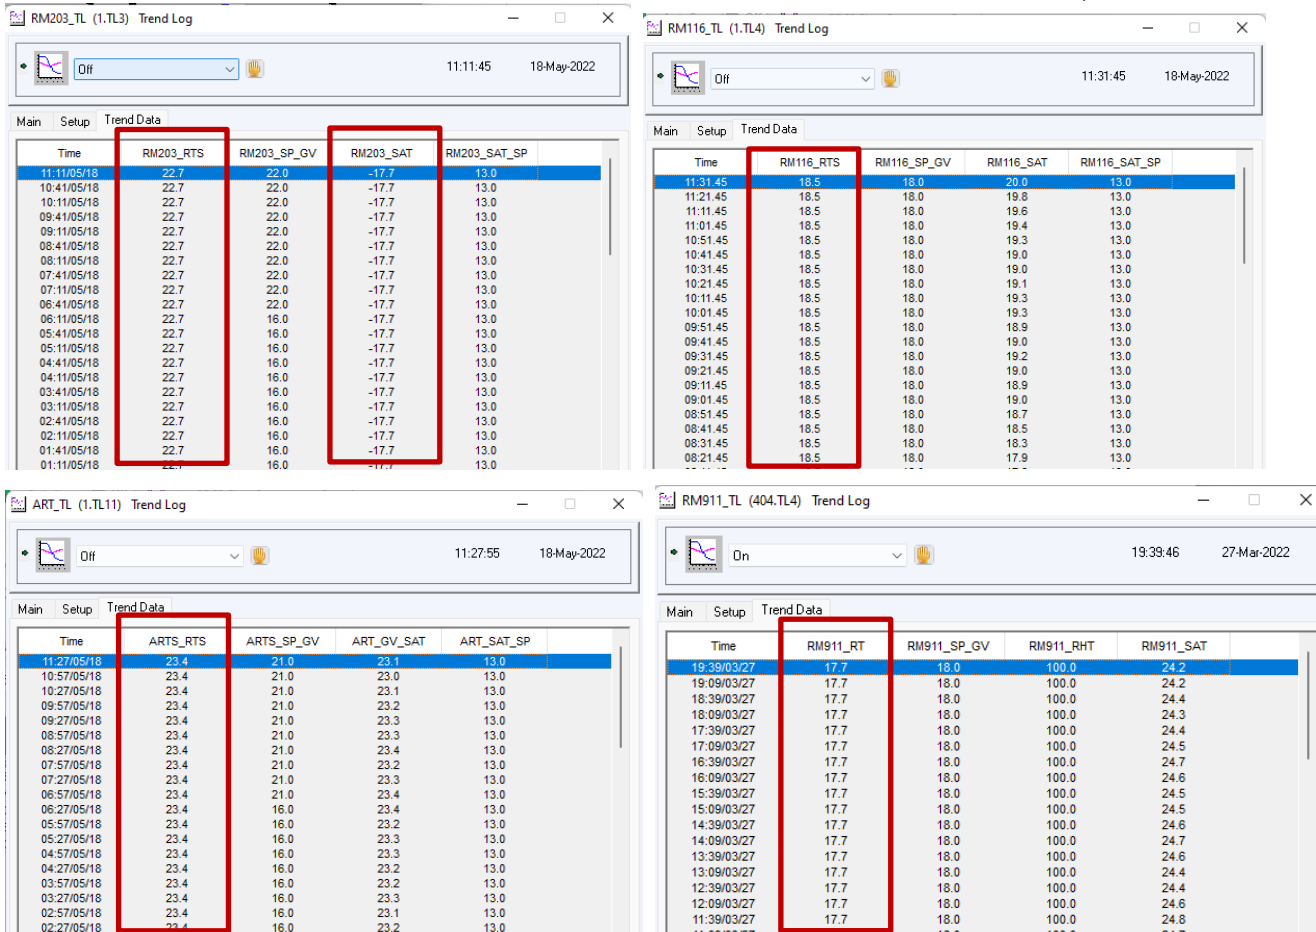
**Figure 24: Failed room temperature and SAT sensors for RM201, 202, 203, 116, ART ROOM, 911**

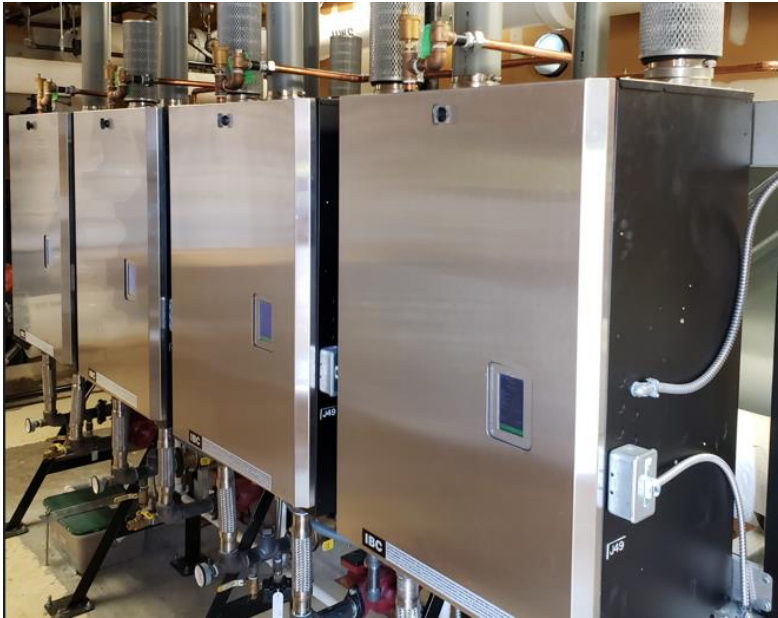
A boiler plant with eight IBC 399 MBH condensing boilers (Figure 1 and Figure 2) is the main source of heating to both blocks. The primary loop is connected through a low loss header to secondary loops serving heating coils in air handlers, reheat coils, convective heaters and fan coils in entrance ways, radiant panel, and unit heaters. Distribution loops and pumps are shown in Figure 3 and Table 1.

Figure 1: Four of the IBC boilers

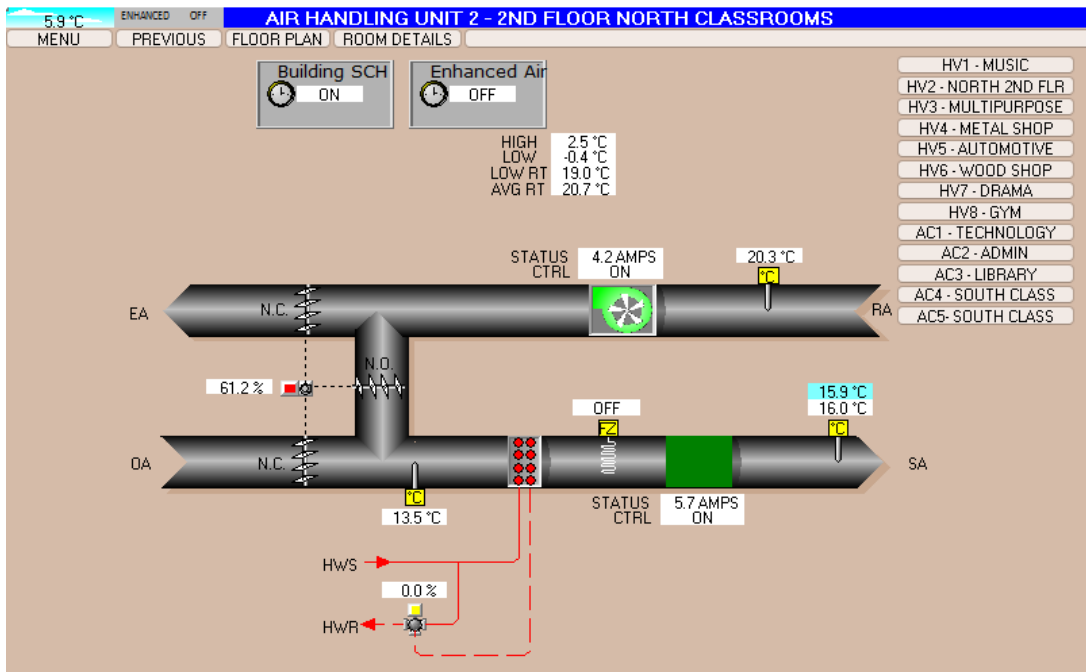
Figure 4: Heat rise across the AHU-2 heating coil is 3.5°C with its control valve closed
