Continuous Optimization for Commercial Buildings Program

# Recommissioning Report

Ballenas Secondary School

Project: BCH-07832

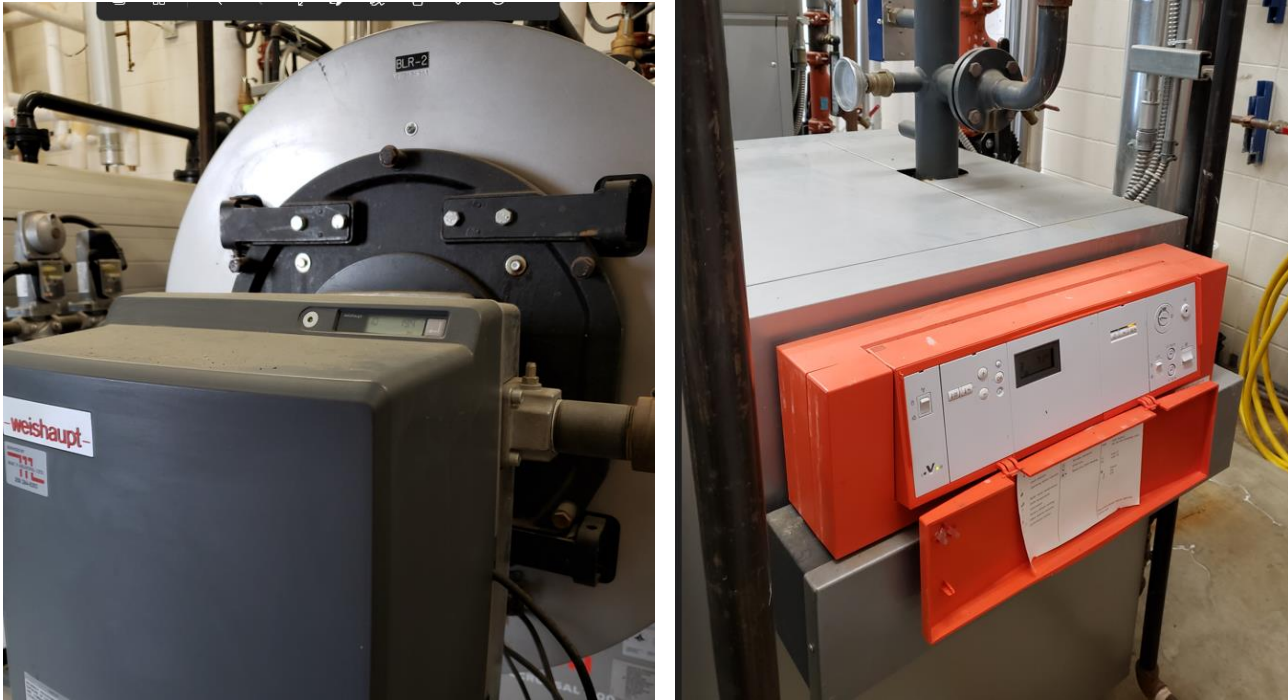
Figure 1: Boilers B-2 (left) and B-3. B-1 is the same make and model as B-2.

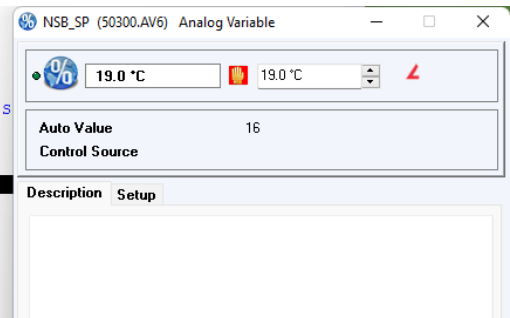
The RM911 room temperature sensor is stuck at 17.7°C which is lower than NSB SP (19°C). During the investigation period, the low RM911 room temperature was observed to trigger HV2A to run during unoccupied times.

**Figure 25: HV2A night setback logic**

Replace the problem temperature sensors.

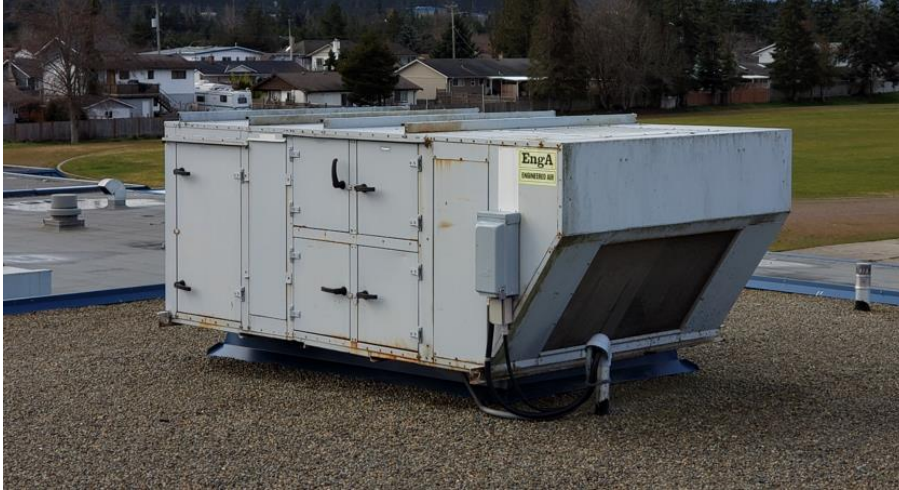
Figure 28: HV11A rooftop unit with DX cooling

Estimated measure costs include all work required to replace each existing cooling system with a reversible heat pump. The base case cost (replacing the equipment like-for-like) may be similar. The ASHRAE life expectancy for air cooled condensers is 20 years, so these units should need to be replaced in 5 to 10 years.

A feasibility study is recommended as the next step to assessing the viability of this project. Mechanical and structural assessments are required to refine the cost and viability of the project.

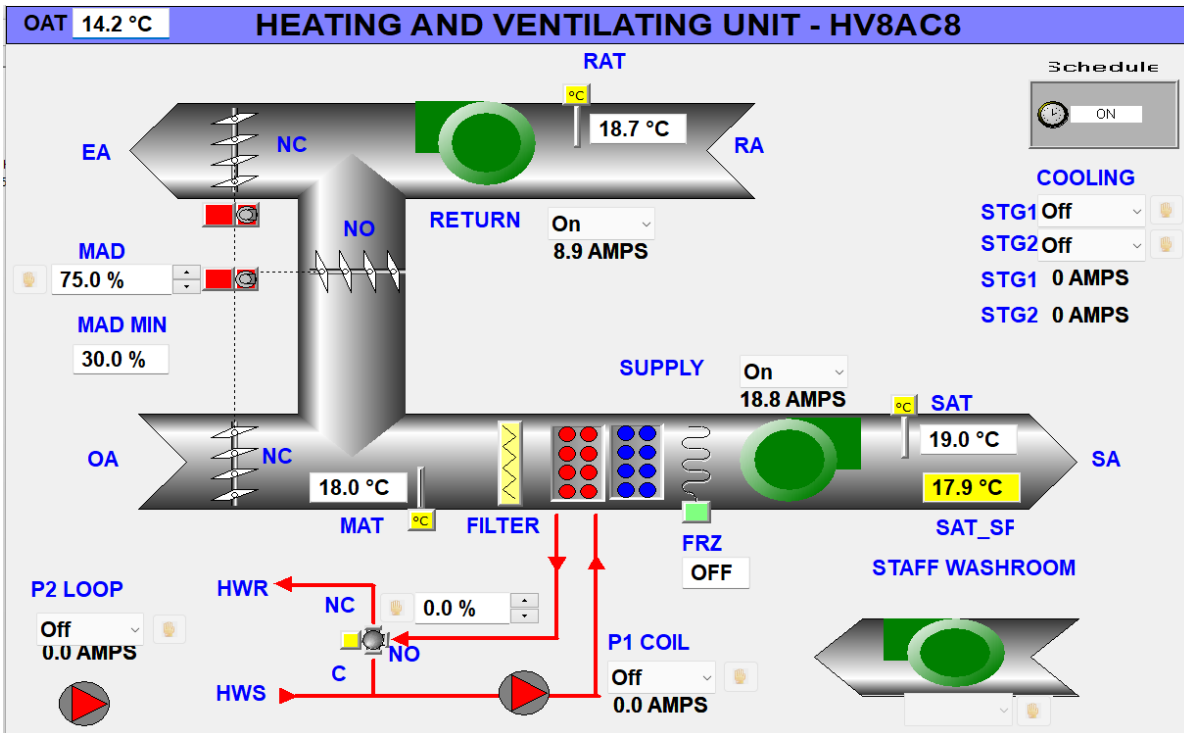
Figure 29: HV8AC8 in the DDC. The unit has two stages of cooling.

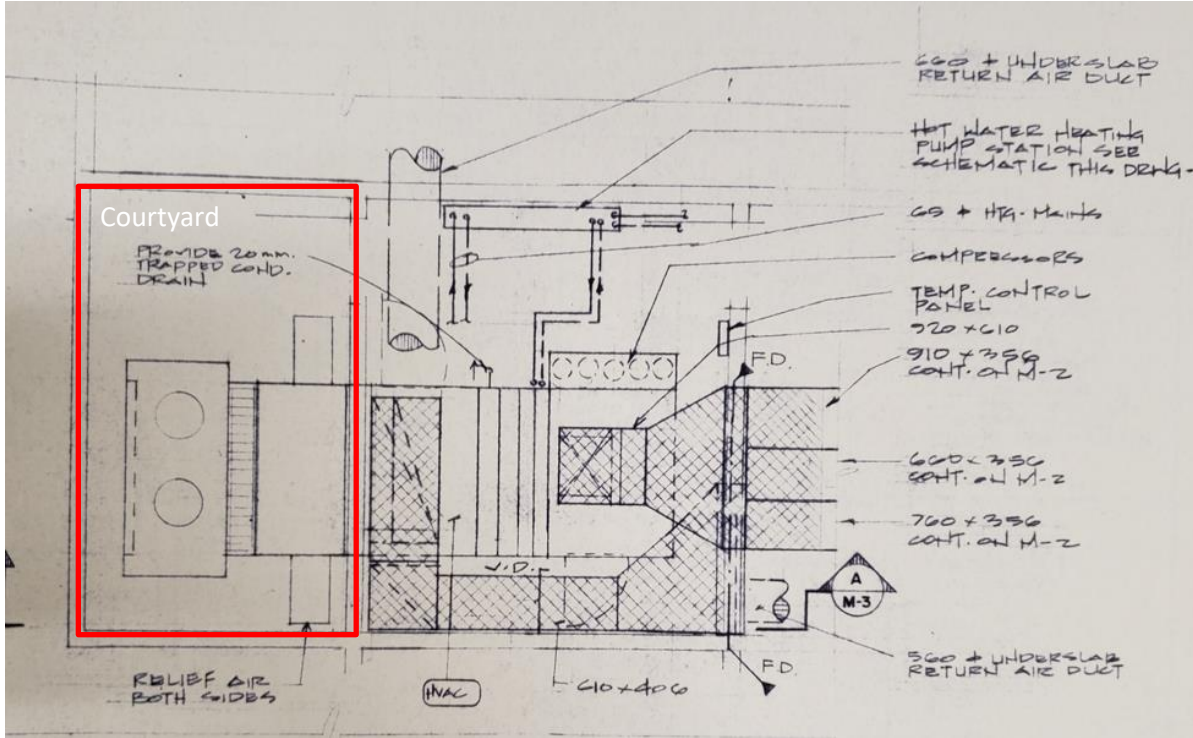
Figure 30: Drawing of HV8AC8. The main unit is inside Mechanical Room 110. The condensing unit is outside in a small courtyard area

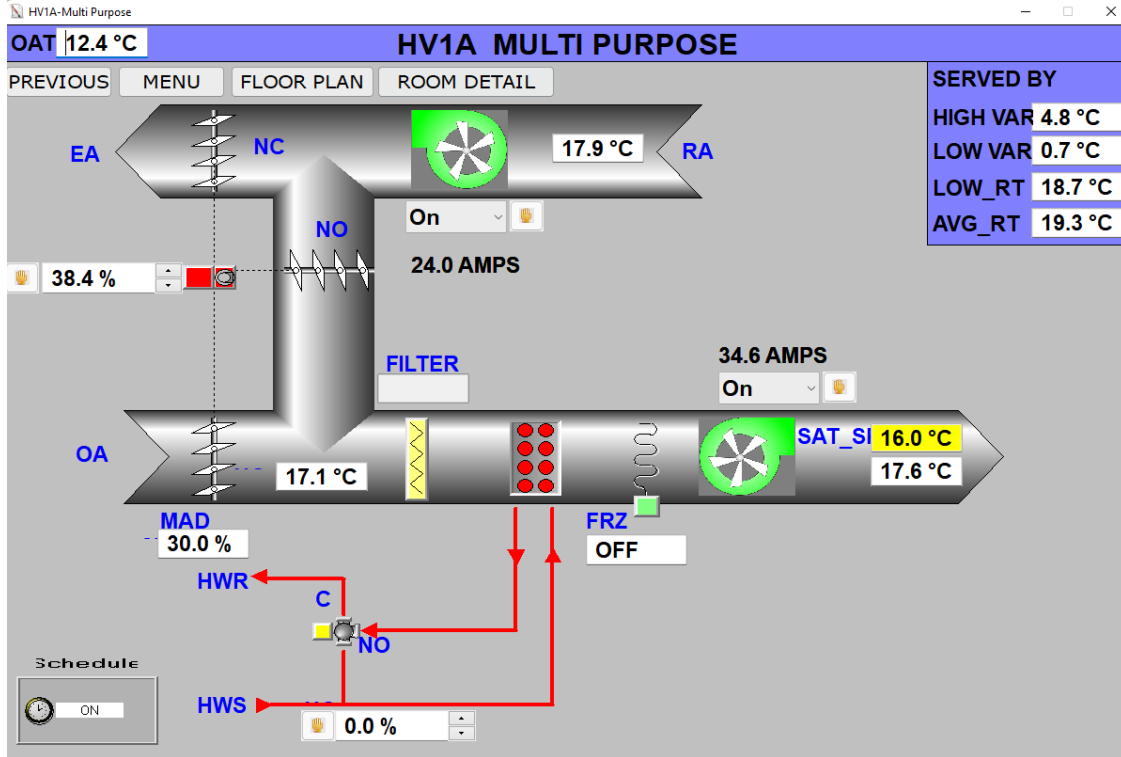
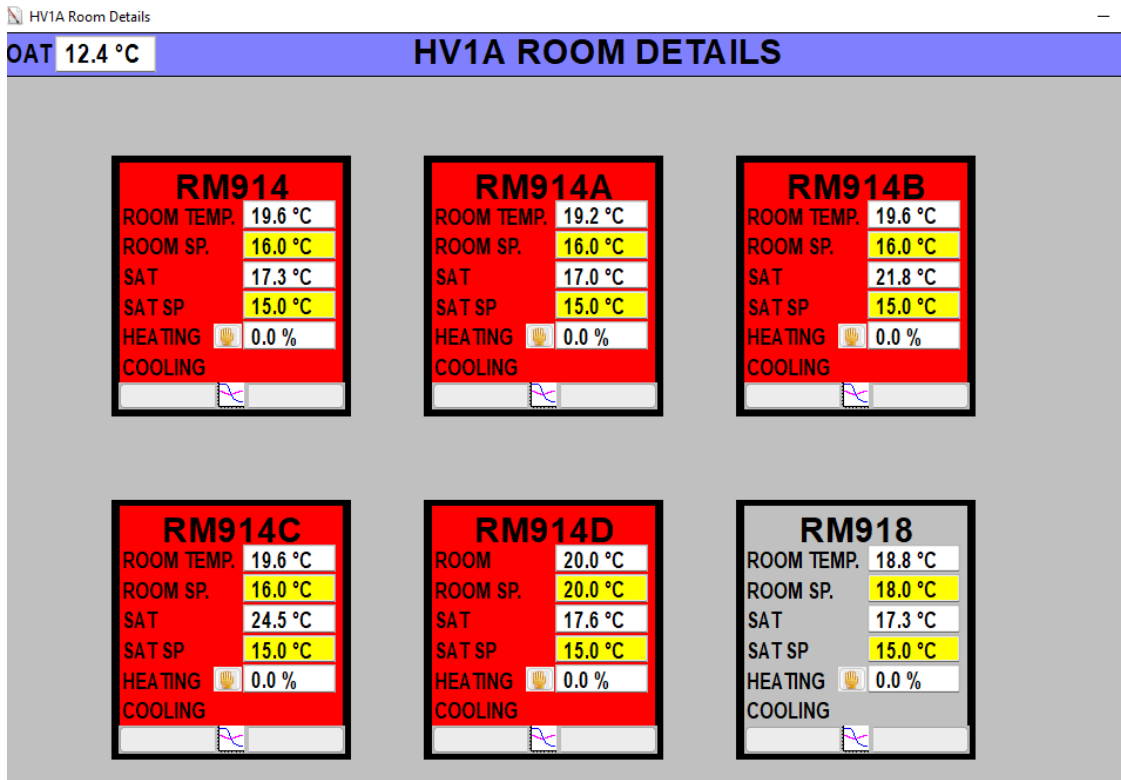
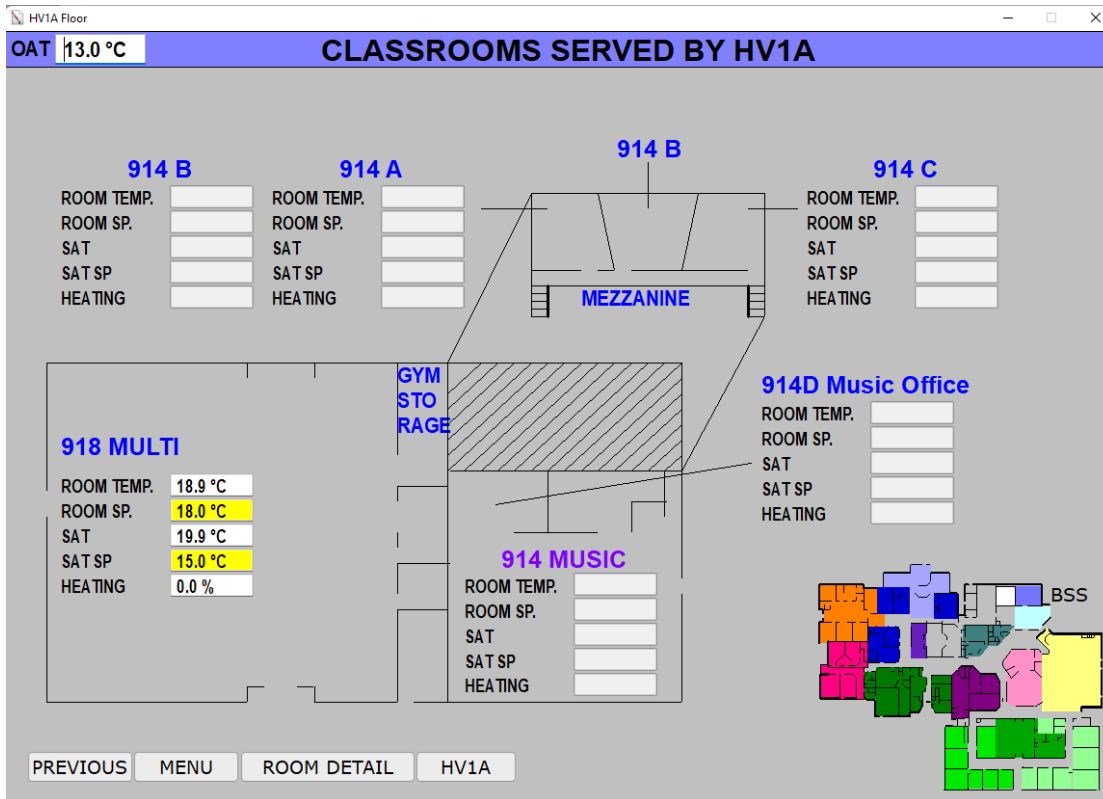
## HV1A

Several reheat coils and their control valves were found to be blocked or passing, see Table 6.

We recommend investigating of all reheat coils in the building to identify coils/valves with issues and diagnosing the issue (valve, coil, or actuator). Some cases may be solved with maintenance, but we expect some valves to need replacement.

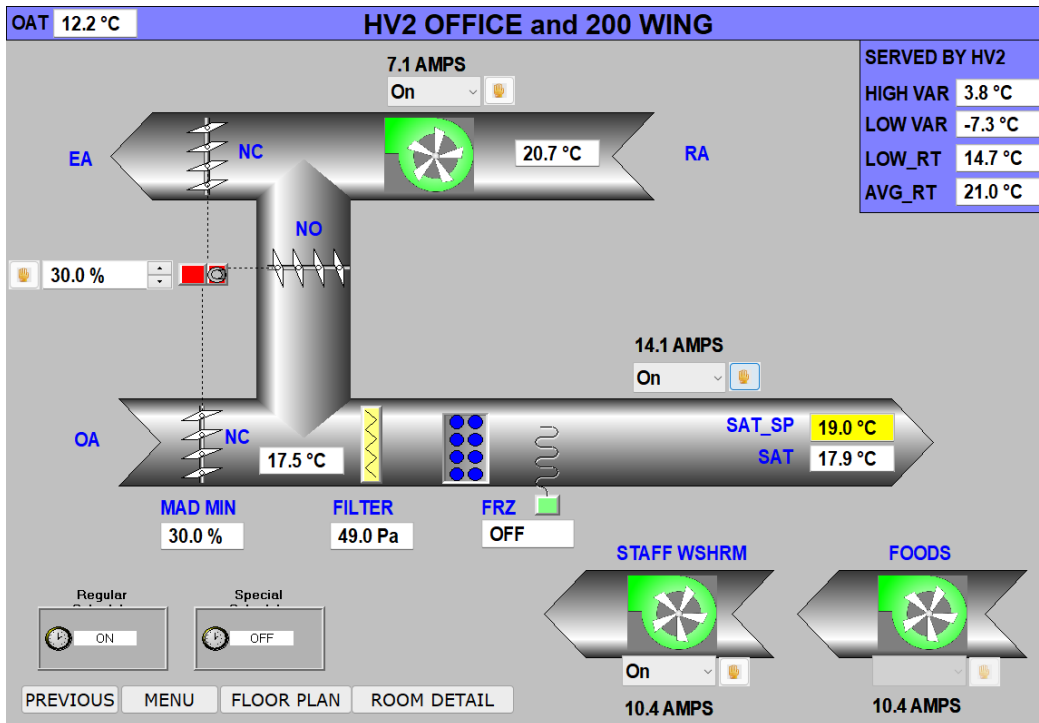
**HV2**

SAT from AHU 17.9C at time of review

<b>RM201</b> ROOM TEMP. 14.7 °C ROOM SP. 22.0 °C SAT -17.7 °C SAT SP 38.0 °C HEATING 50.0 % COOLING	<b>RM202</b> ROOM TEMP. 18.1 °C ROOM SP. 22.0 °C SAT -17.7 °C SAT SP 38.0 °C HEATING 50.0 % COOLING	<b>RM203</b> ROOM TEMP. 22.7 °C ROOM SP. 22.0 °C SAT 17.9 °C SAT SP 22.0 °C HEATING 50.0 % COOLING	<b>RM116</b> ROOM TEMP. 18.5 °C ROOM SP. 18.0 °C SAT 18.1 °C SAT SP 13.0 °C HEATING 50.0 % COOLING
<b>COPY153</b> ROOM TEMP. 20.1 °C ROOM SP. 20.0 °C SAT 18.0 °C SAT SP 30.7 °C HEATING 50.0 % COOLING	<b>V.P.</b> ROOM TEMP. 23.0 °C ROOM SP. 22.0 °C SAT 18.1 °C SAT SP 13.0 °C HEATING 50.0 % COOLING	<b>PRINCIPAL</b> ROOM TEMP. 22.9 °C ROOM SP. 22.0 °C SAT 18.1 °C SAT SP 18.3 °C HEATING 50.0 % COOLING	<b>ADMIN</b> ROOM TEMP. 24.2 °C ROOM SP. 23.0 °C SAT 29.1 °C SAT SP 13.0 °C HEATING 50.0 % COOLING
<b>RM145</b> ROOM TEMP. 23.8 °C ROOM SP. 20.0 °C SAT 18.4 °C SAT SP 15.0 °C HEATING 0.0 % COOLING	<b>RM147</b> ROOM TEMP. 20.0 °C ROOM SP. 22.0 °C SAT 27.9 °C SAT SP 35.0 °C HEATING 100.0 % COOLING	<b>ART ROOM</b> ROOM TEMP. 23.4 °C ROOM SP. 21.0 °C SAT 22.7 °C SAT SP 13.0 °C HEATING 50.0 % COOLING
